DO15 RC Indoor Phase VI Test Daily Notes

Date: August 01, 2019

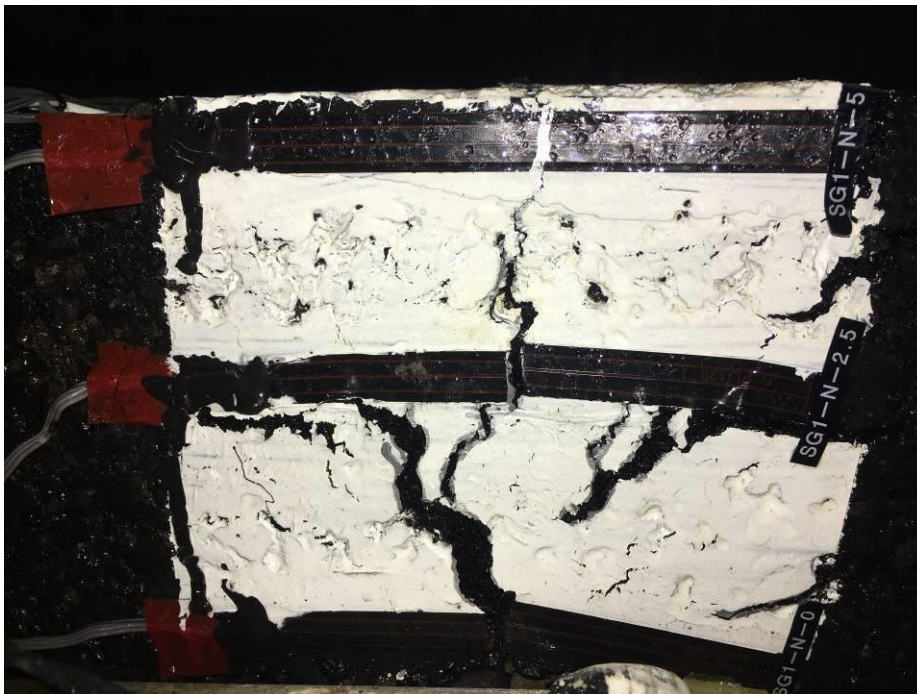
- Completed cracked, no further change.
- Bottom up crack at inner vertical edge as seen in Fig 1. Bottom up crack at outer vertical edge as seen in Fig 2.
- Surface crack connected to the bottom-up crack of the outer edge as seen in Fig 3, and the inner vertical edge shown in Fig 4.

Fig 1 Bottom-up crack at north section inner vertical edge reached top surface

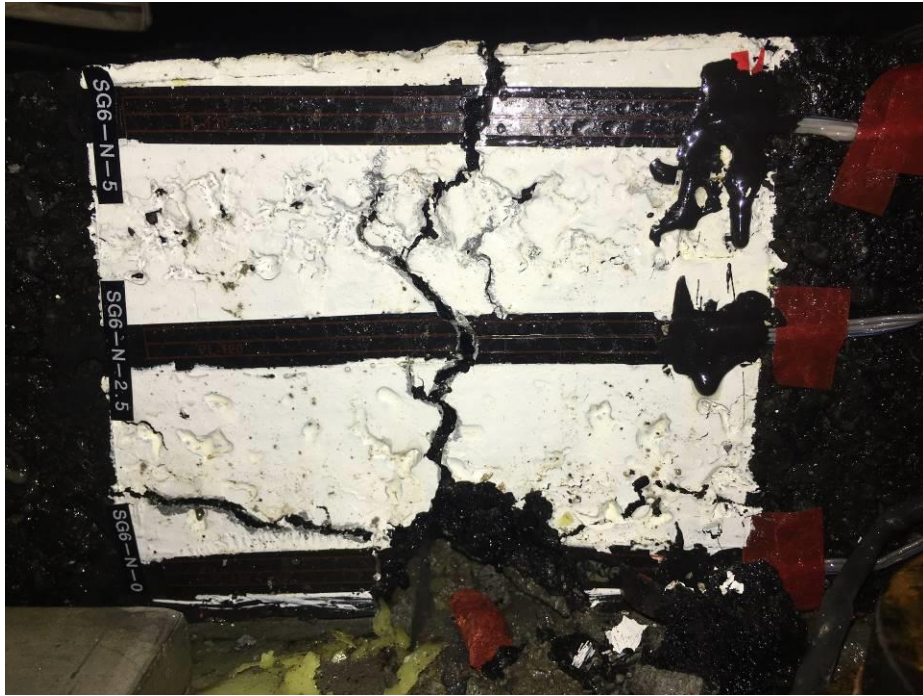
Fig 2 Bottom-up crack at north section outer edge reached top surface

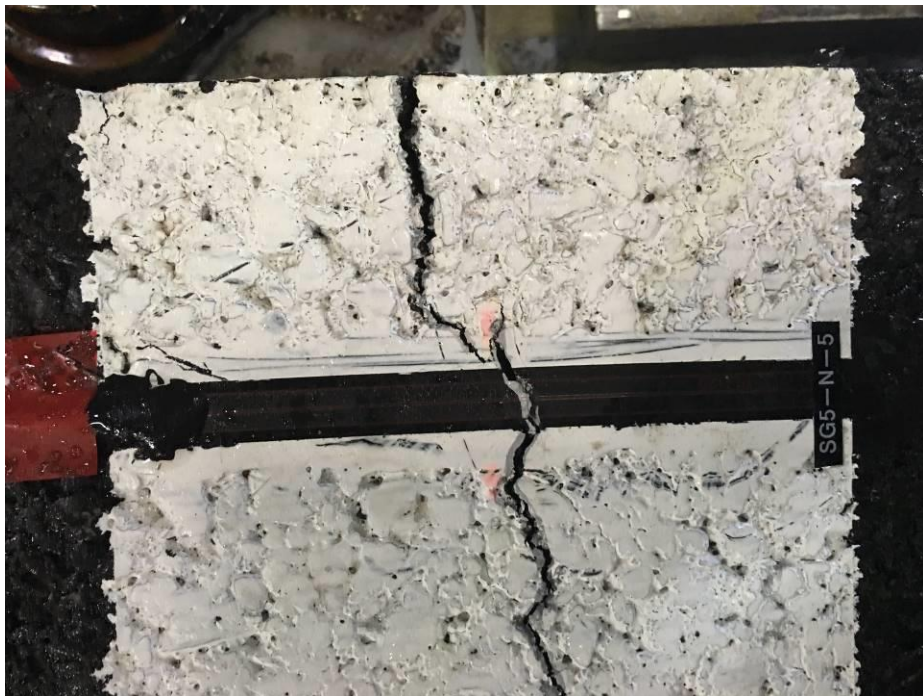
Fig 3 Surface crack on North Section reached outer edge

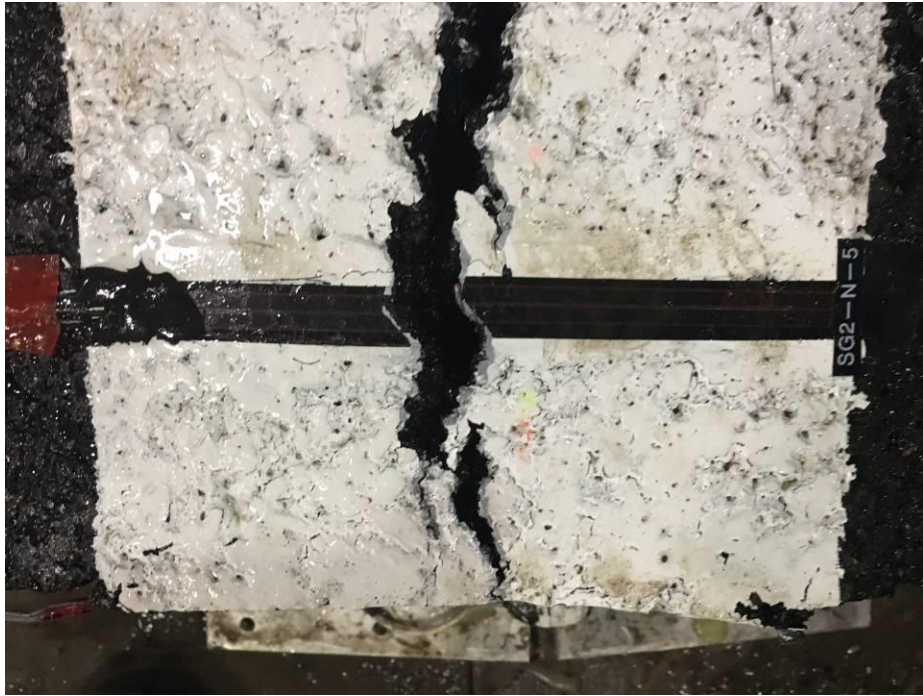
Fig 4 North section surface crack reached inner vertical edge

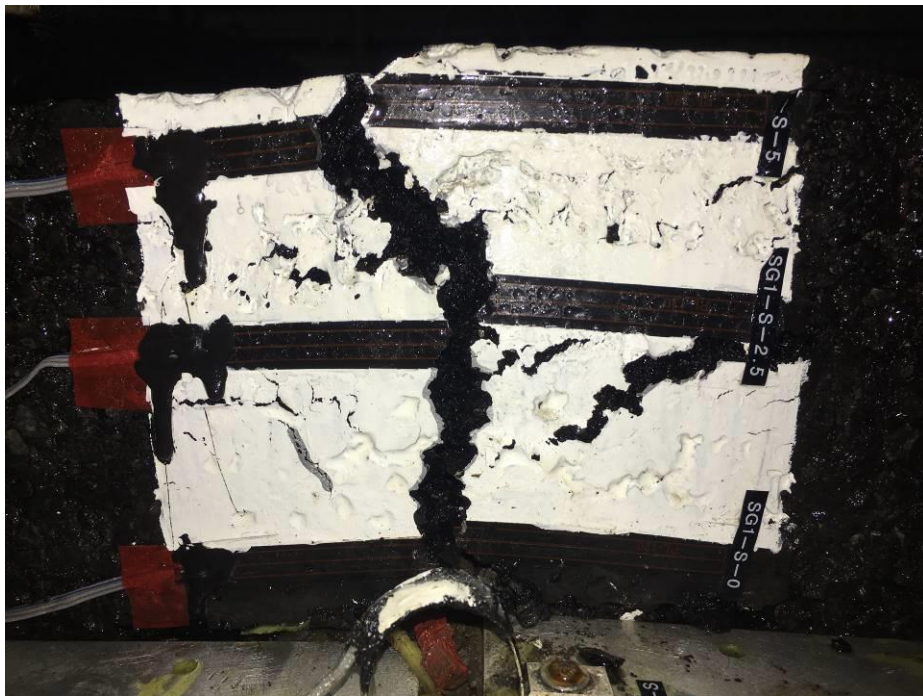
- No change from last observation.
- Bottom up crack at inner vertical edge shown in Fig5. Bottom up crack at outer vertical edge measured approximately 3.5 inch as shown in Fig 6.
- Surface crack reached the inner vertical edge as shown in Fig 7, approximately 3 inches from the outer vertical edge, no change as seen in Fig 8.

Fig 5 Bottom-up crack at inner vertical edge of south section reached top surface

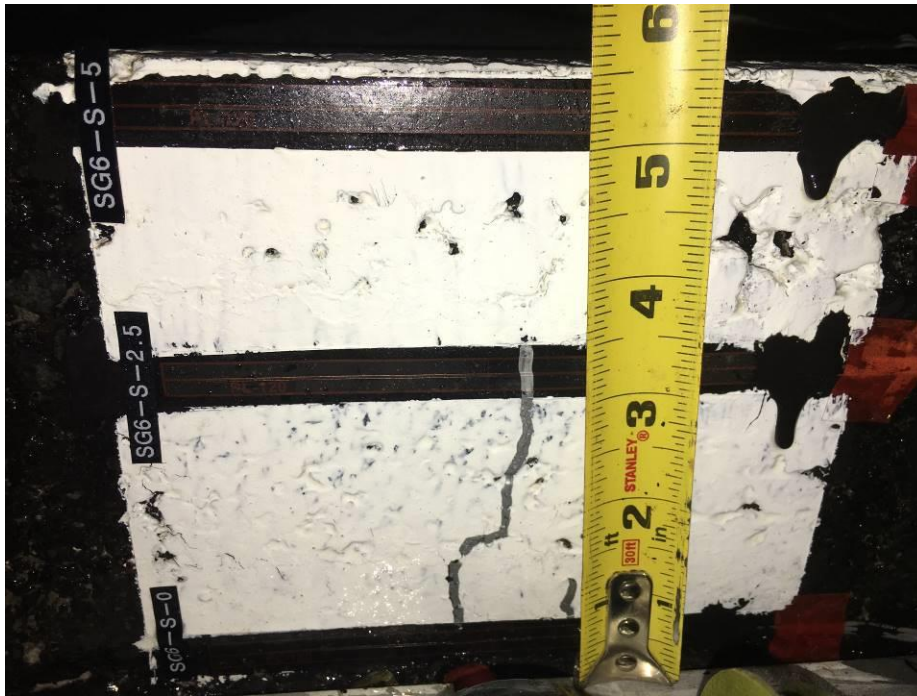
Fig 6 Bottom-up crack at SG6-S-0, SG6-S-2.5 approximately 3.5 inch long

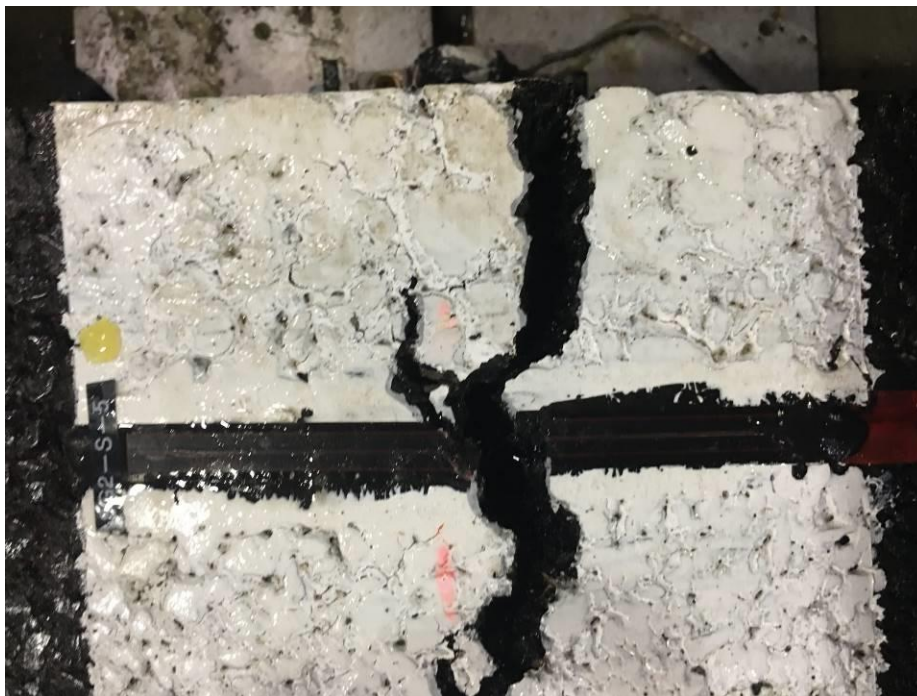
Fig 7 South section surface crack reached the inner vertical edge

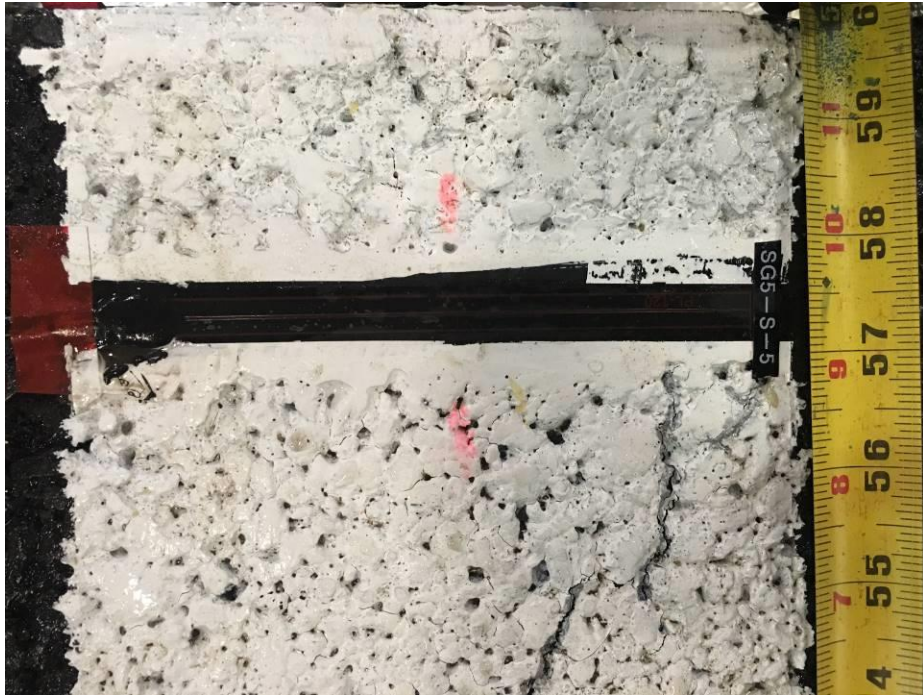
Fig 8 South section surface crack 3 inches from the outer vertical edge

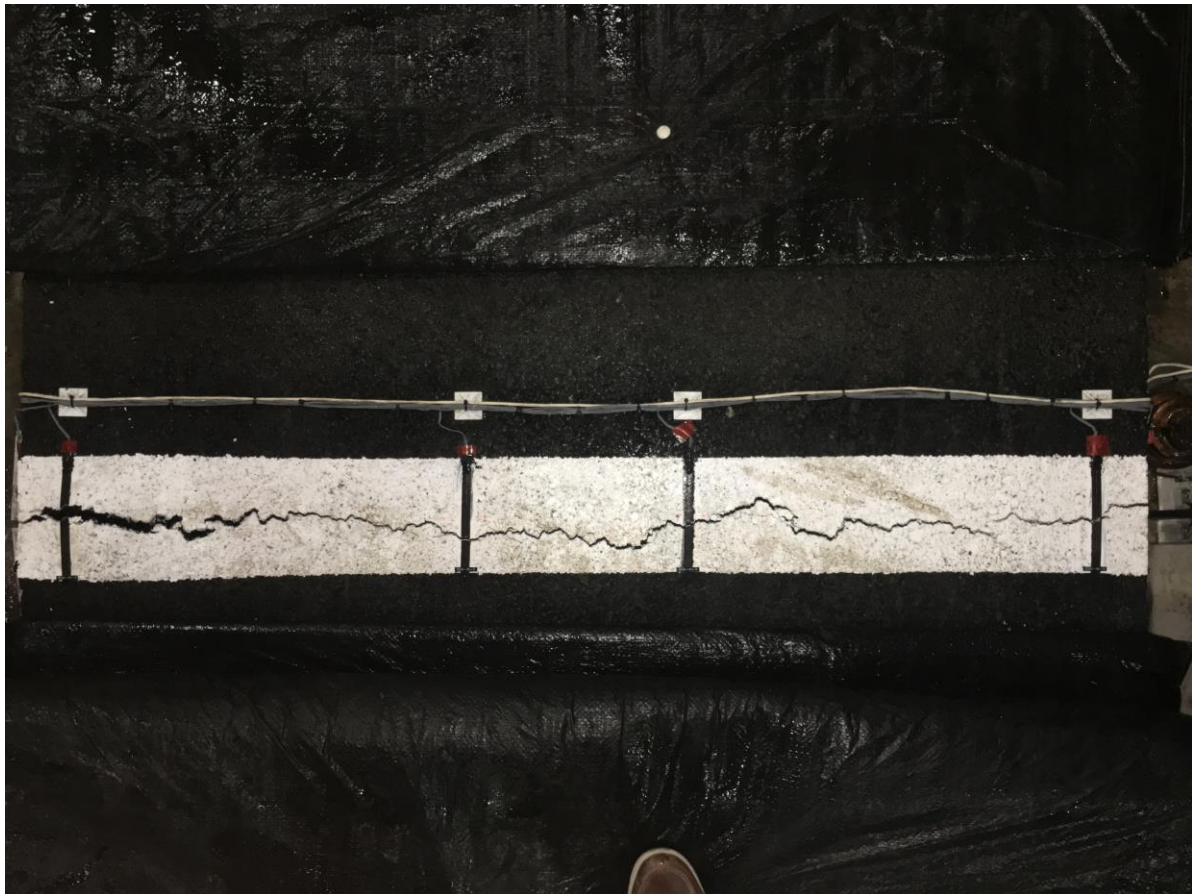
Fig 8 North Section Surface Crack

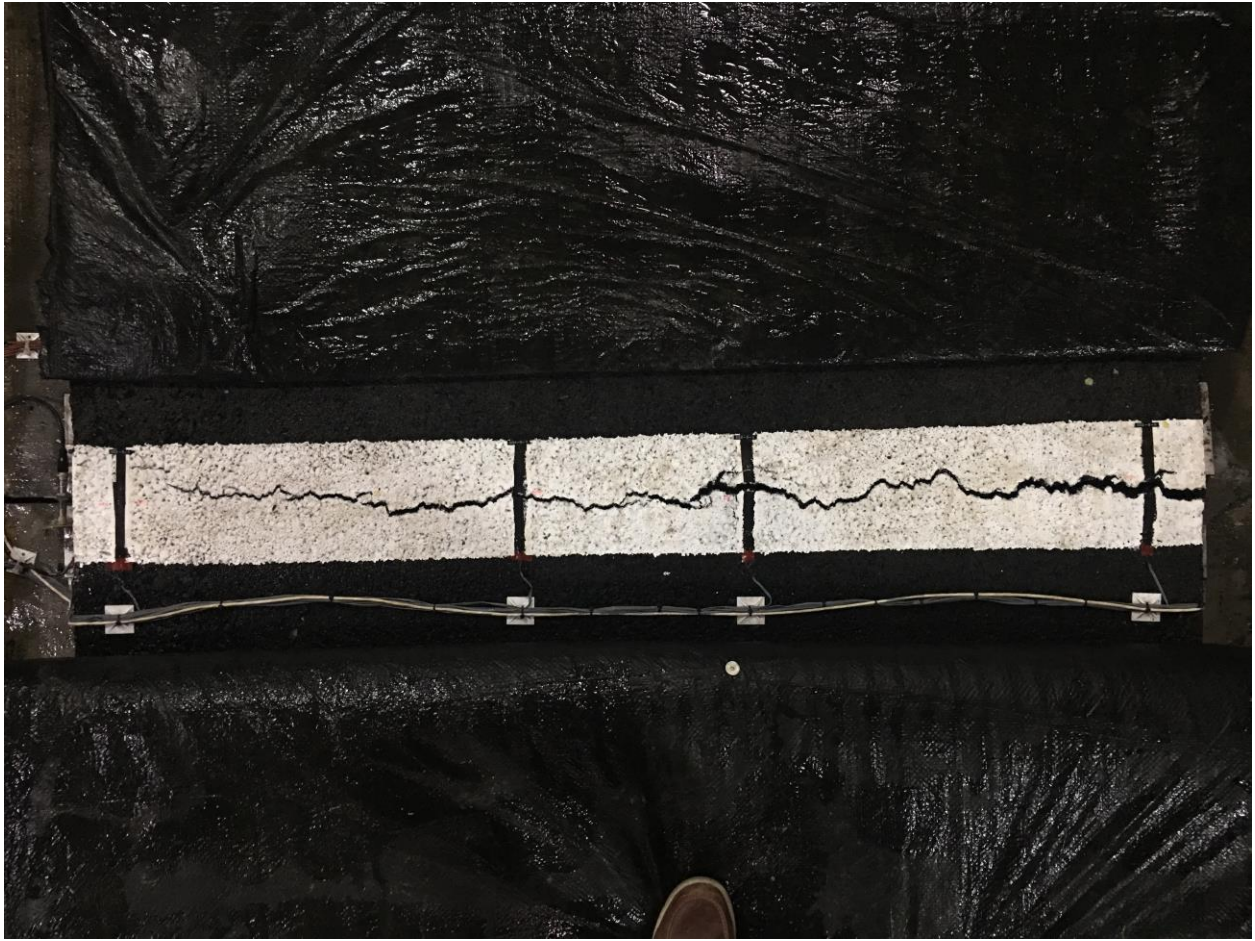
Fig 8 South Section Surface Crack
