DO15 RC Indoor Phase VI Test Daily Notes

Date: July 12, 2019

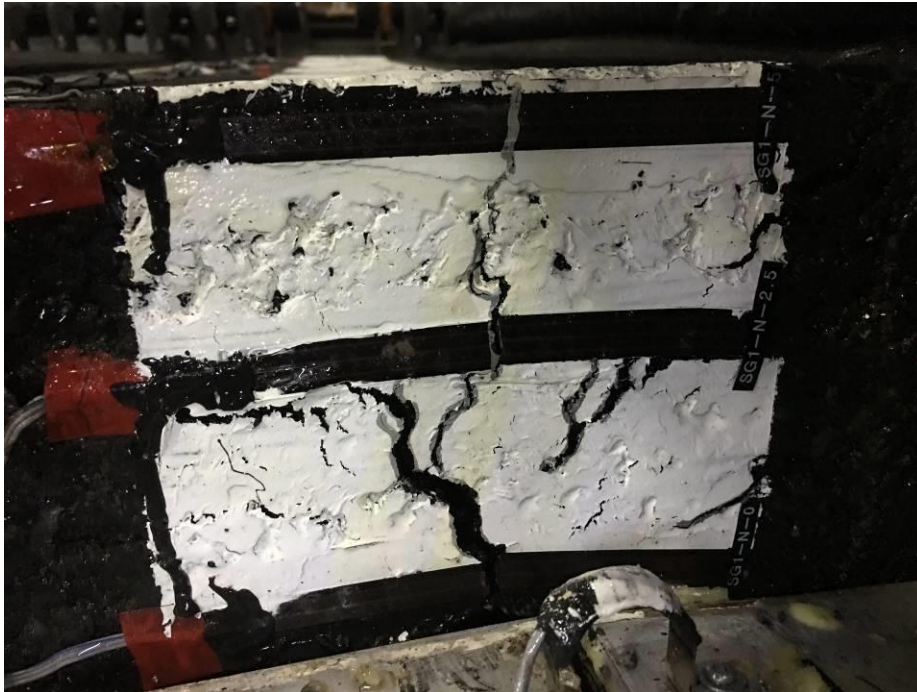
- No change from last observation.
- Bottom up crack at inner vertical edge (Fig 1). Bottom up crack at outer vertical edge (Fig 2).
- Surface crack connected to the bottom-up crack of the outer edge (Fig 3), and the inner vertical edge (Fig 4).

Fig 1 Bottom-up crack at north section inner vertical edge reached top surface

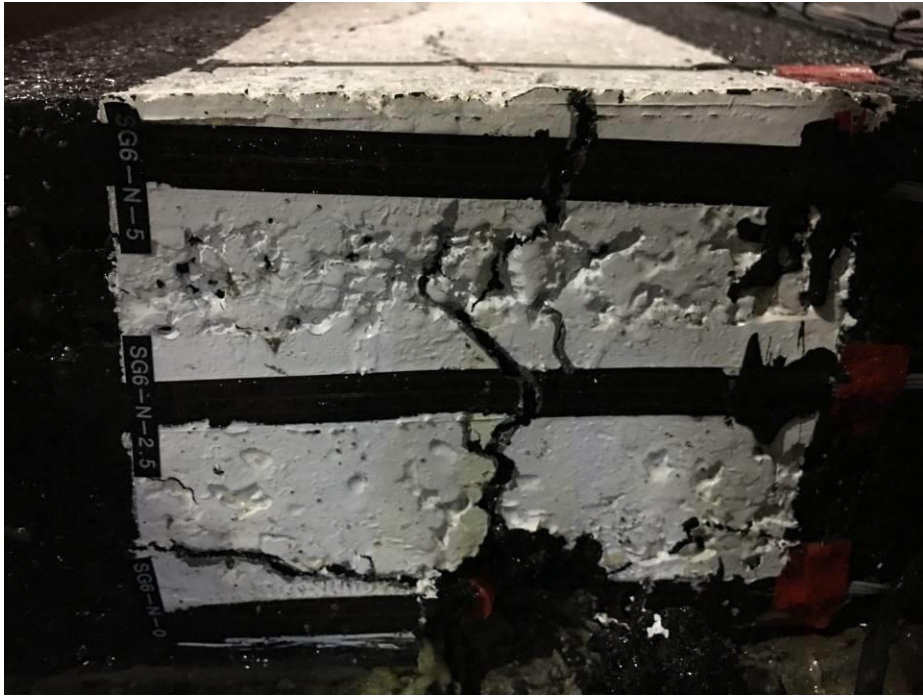
Fig 2 Bottom-up crack at north section outer edge reached top surface

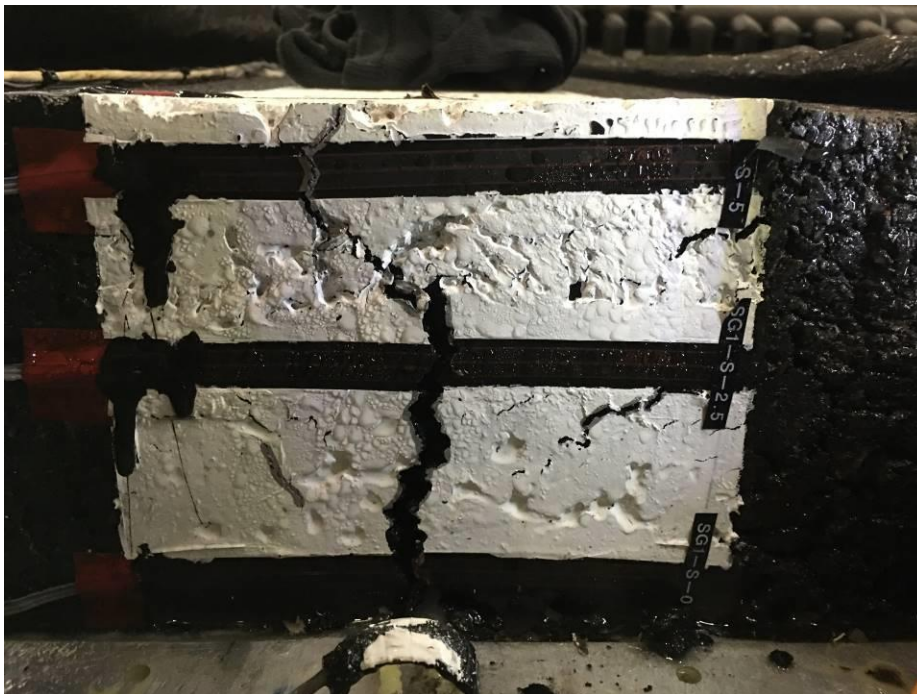
- No change from last observation.
- Bottom up crack at inner vertical edge (Fig5). Bottom up crack at outer vertical edge (Fig 6).
- Surface crack reached the inner vertical edge (Fig 7), approximately 3 inches from the outer vertical edge, no change (Fig 8)

Fig 5 Bottom-up crack at inner vertical edge of south section reached top surface

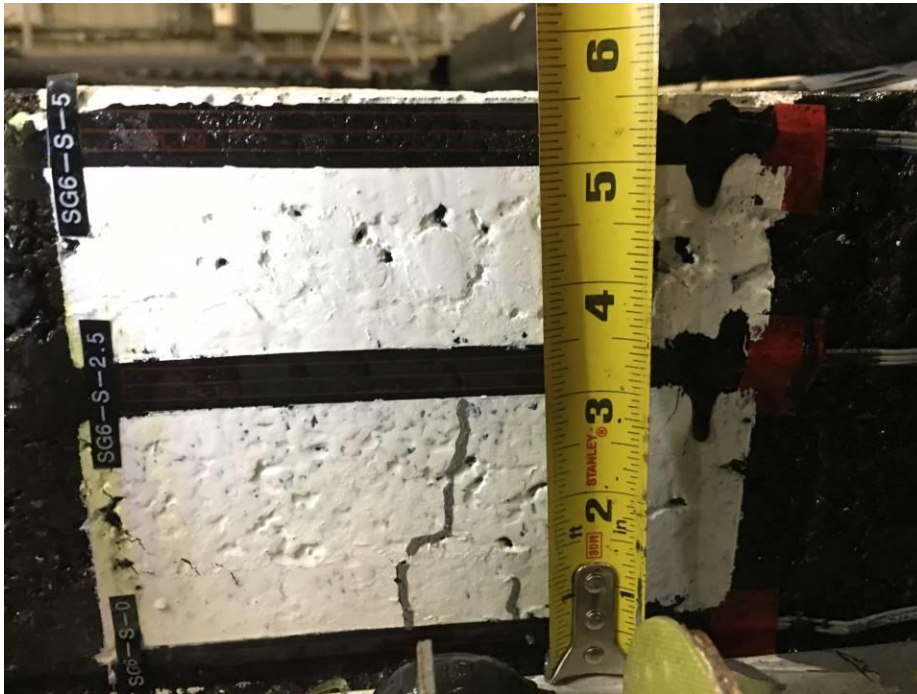
Fig 6 Bottom-up crack at SG6-S-0 3 inch long
