DO15 RC Indoor Phase VI Test Daily Notes

Date: July 22, 2019

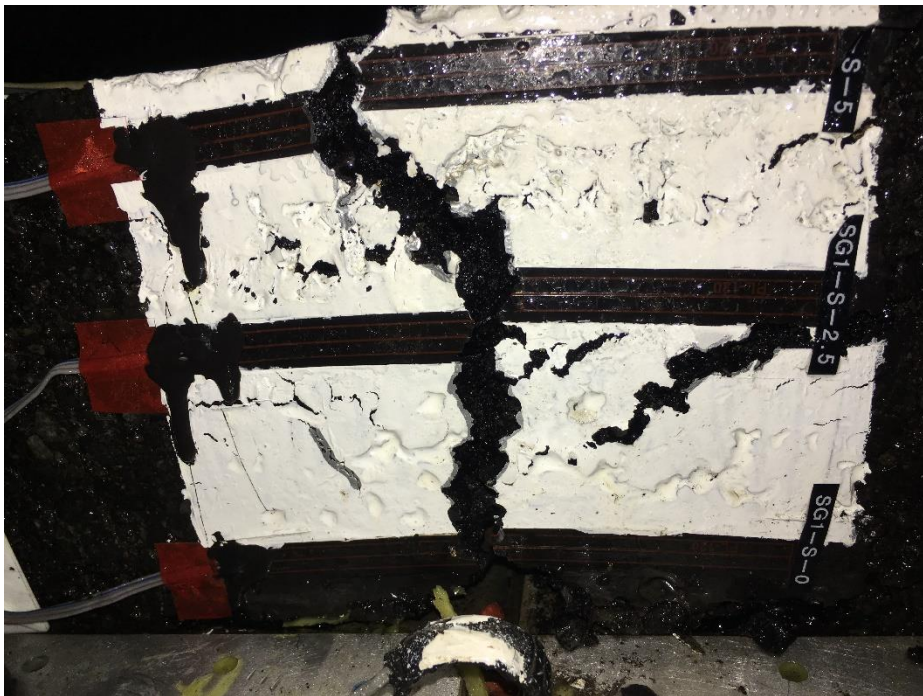
Fig 5 Bottom-up crack at inner vertical edge of south section reached top surface
