DO15 RC Indoor Phase VI Test Daily Notes

Date: July 19, 2019

Cycle count: 4373

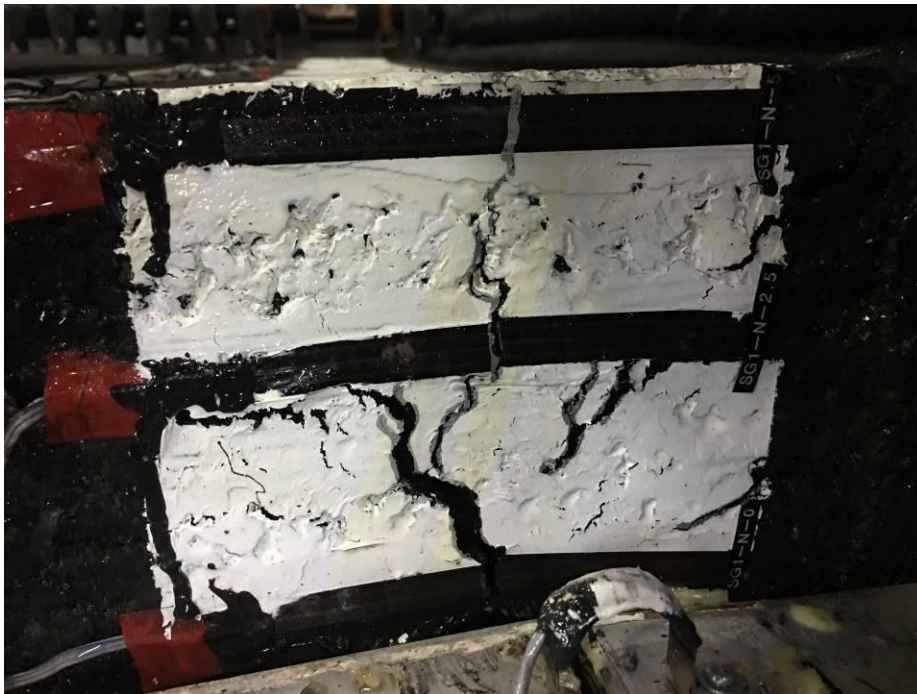
Fig 1 Bottom-up crack at north section inner vertical edge reached top surface

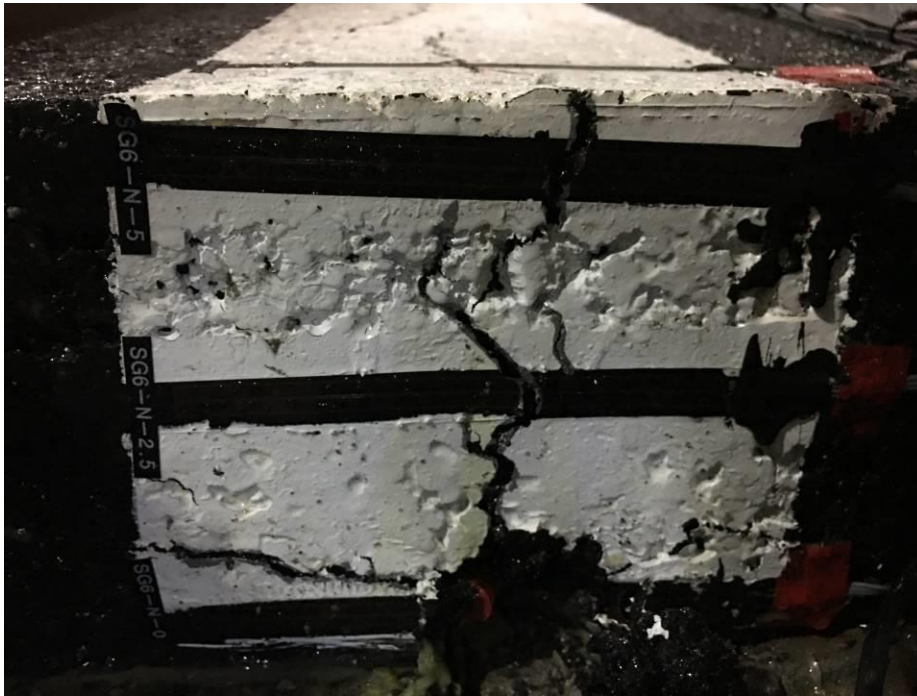
Fig 2 Bottom-up crack at north section outer edge reached top surface

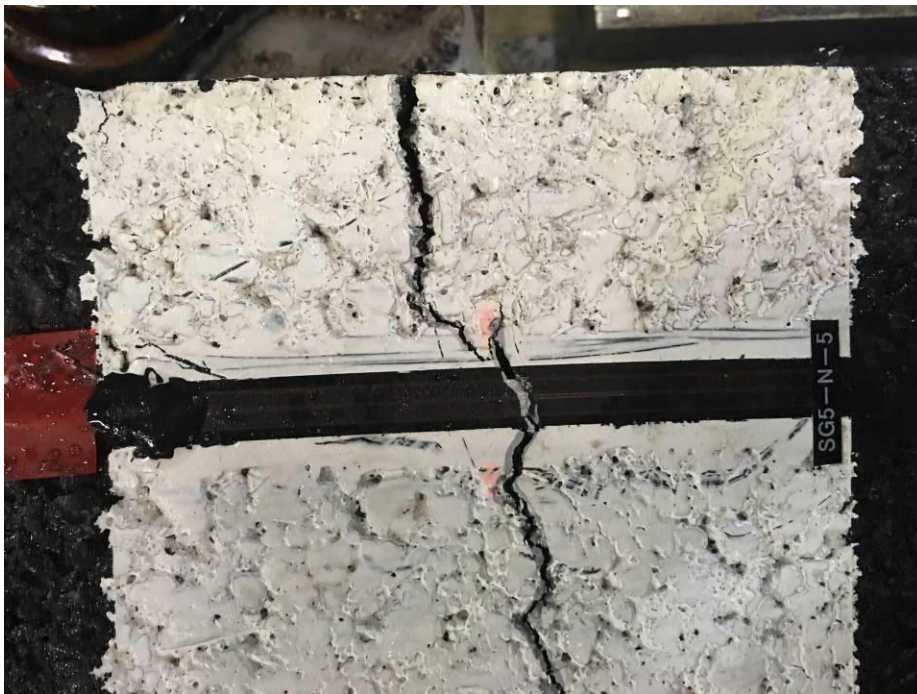
Fig 3 Surface crack on North Section reached outer edge

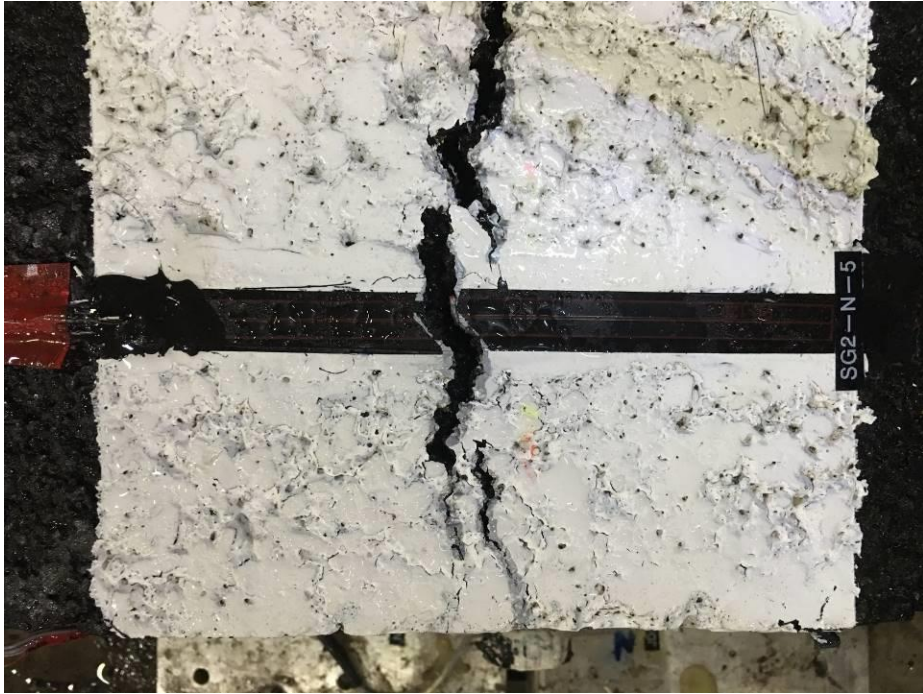
Fig 4 North section surface crack reached inner vertical edge

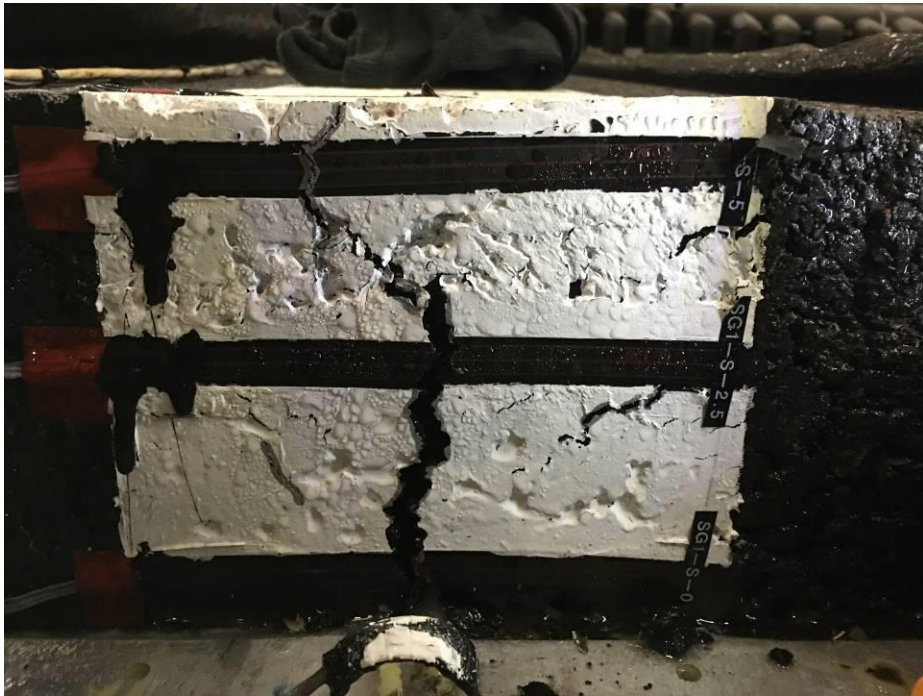
Fig 5 Bottom-up crack at inner vertical edge of south section reached top surface
