## DO15 RC Indoor Phase VI Test Daily Notes

*Date: August 02, 2019*

*Cycle count: 6029*

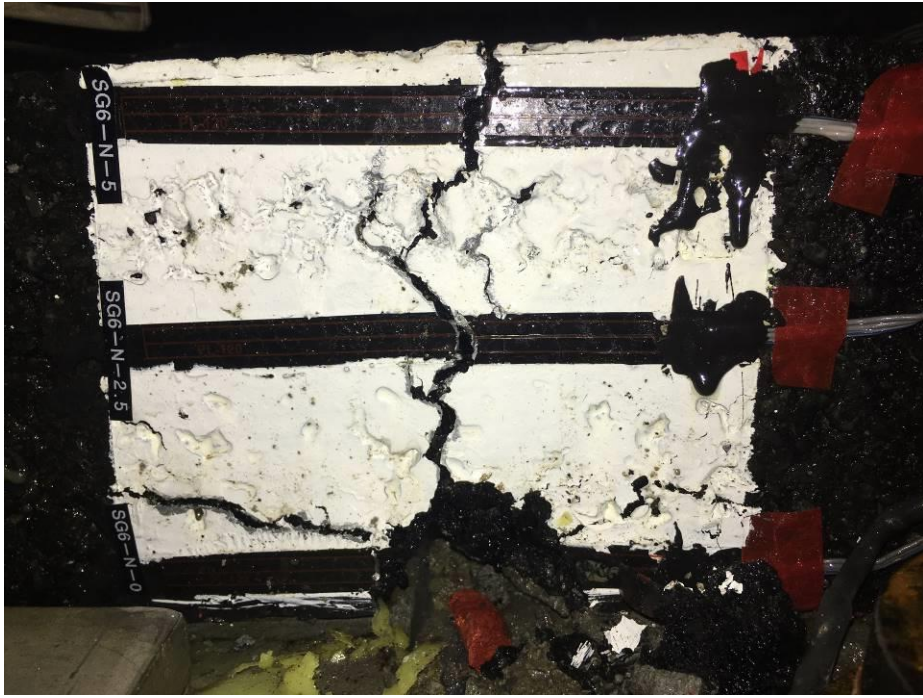
Fig 2 Bottom-up crack at north section outer edge reached top surface

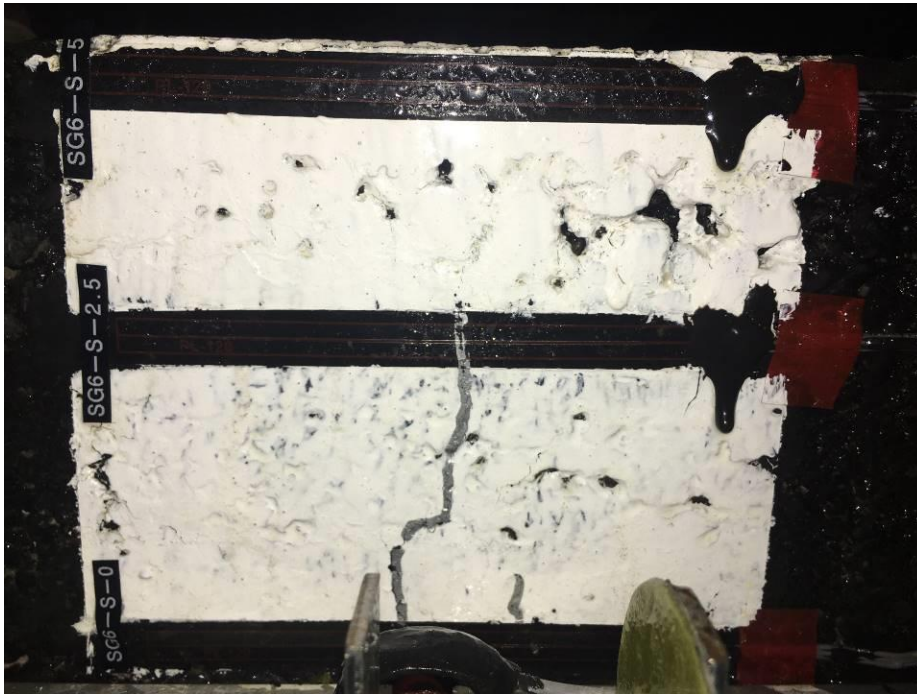
Fig 6 Bottom-up crack at SG6-S-0, SG6-S-2.5 approximately 3.5 inch long

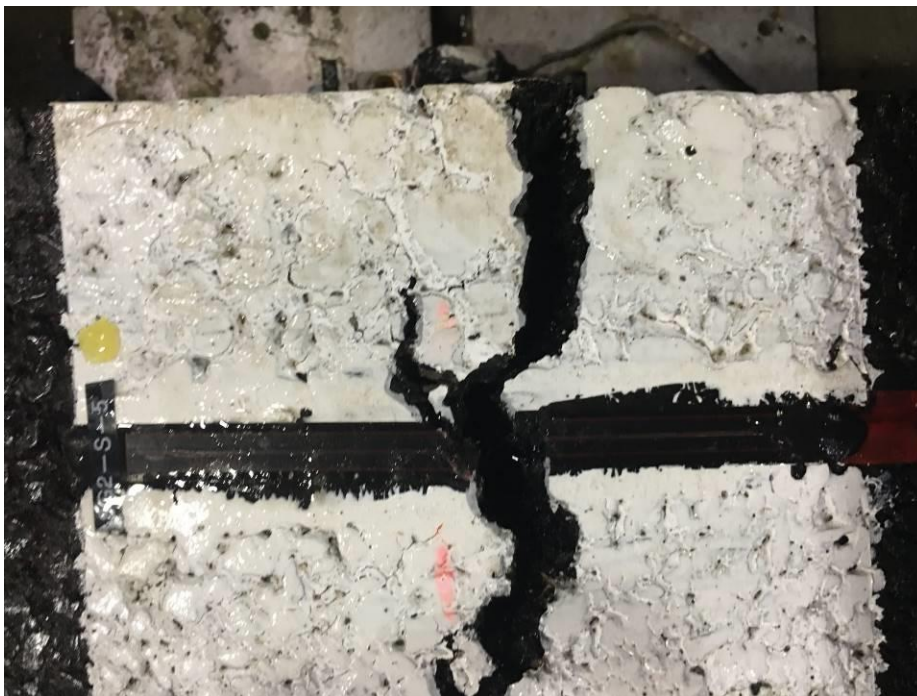
Fig 7 South section surface crack reached the inner vertical edge

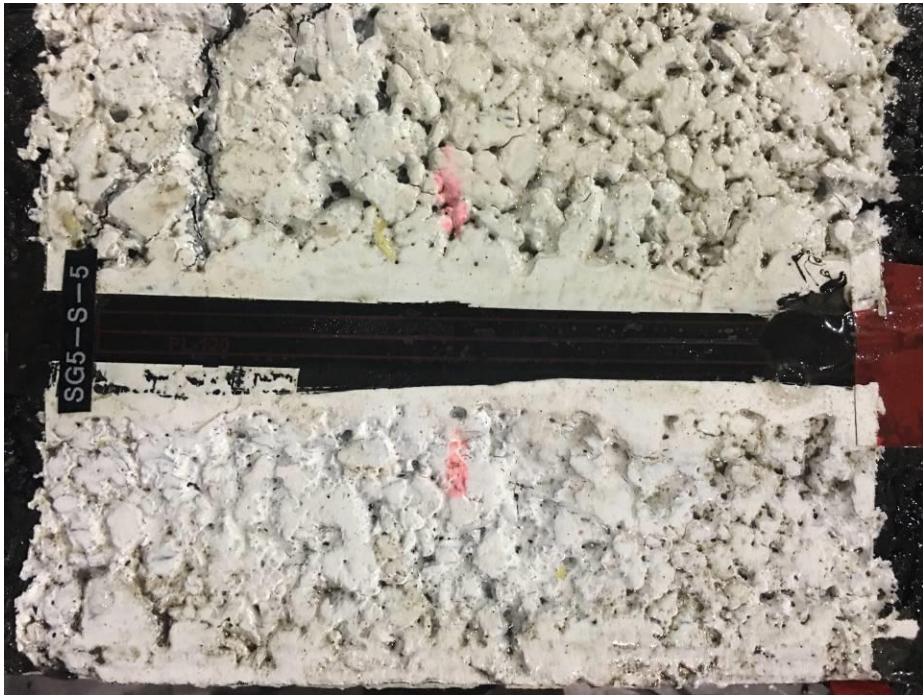
Fig 8 South section surface crack 3 inches from the outer vertical edge
