## DO15 RC Indoor Phase VI Test Daily Notes

*Date: July 23, 2019*

*Cycle count: 4845*

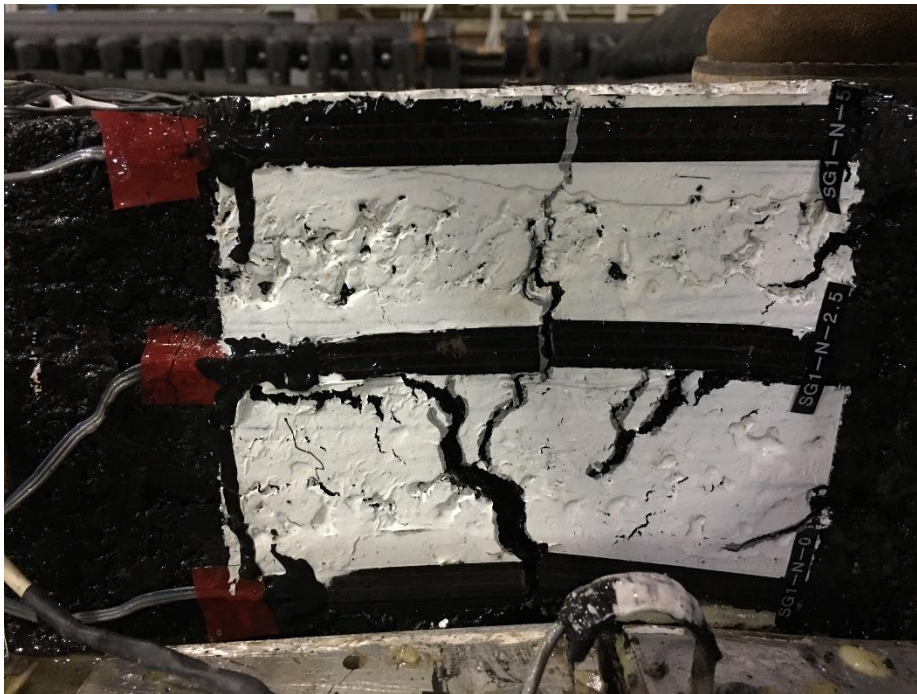
- Completed cracked, no further change.
- Bottom up crack at inner vertical edge (Fig 1). Bottom up crack at outer vertical edge (Fig 2).
- Surface crack connected to the bottom-up crack of the outer edge (Fig 3), and the inner vertical edge (Fig 4).

Fig 1 Bottom-up crack at north section inner vertical edge reached top surface

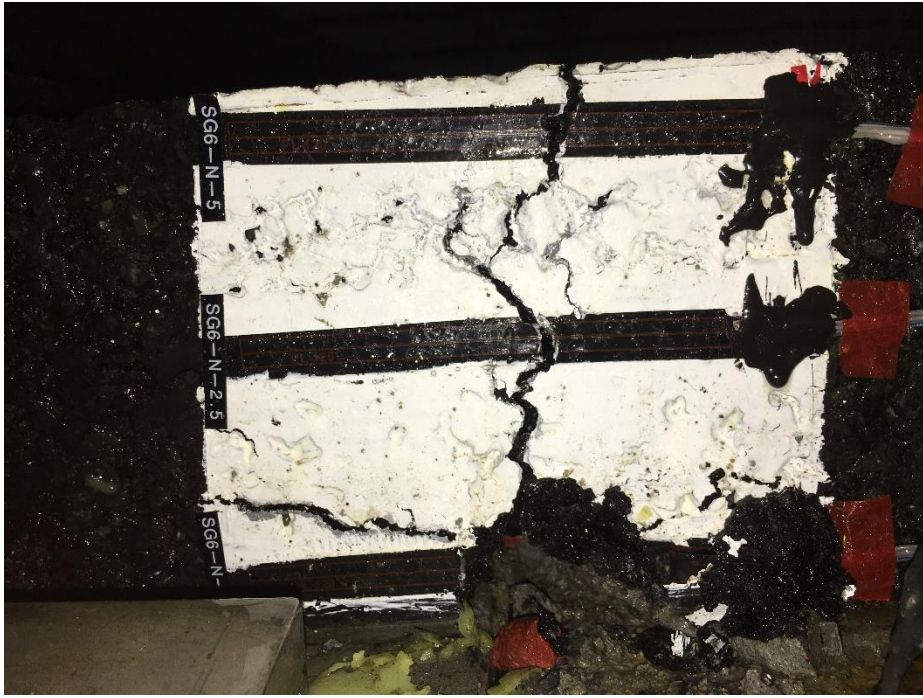
Fig 2 Bottom-up crack at north section outer edge reached top surface

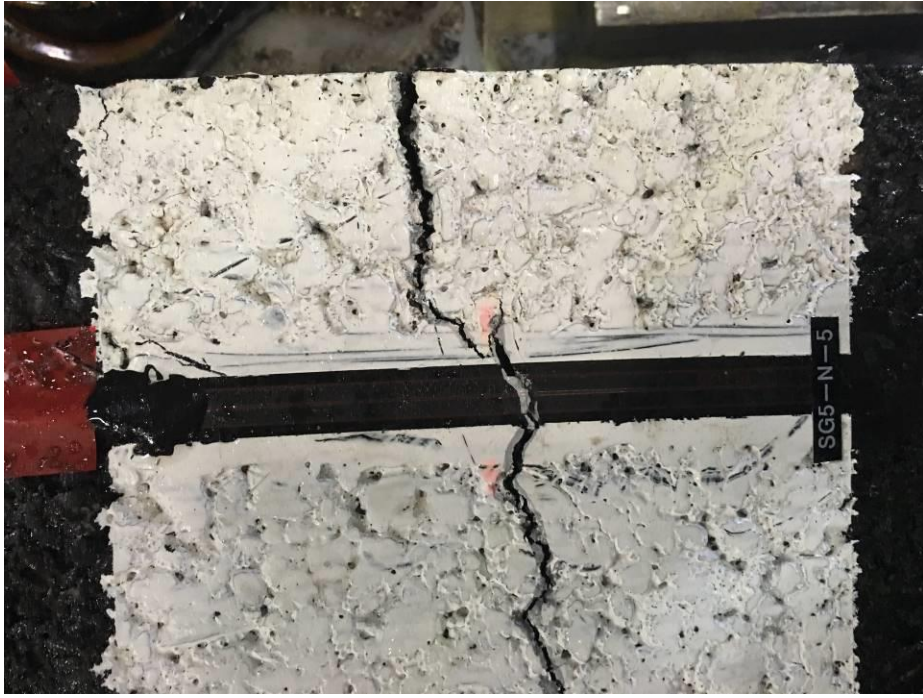
Fig 3 Surface crack on North Section reached outer edge

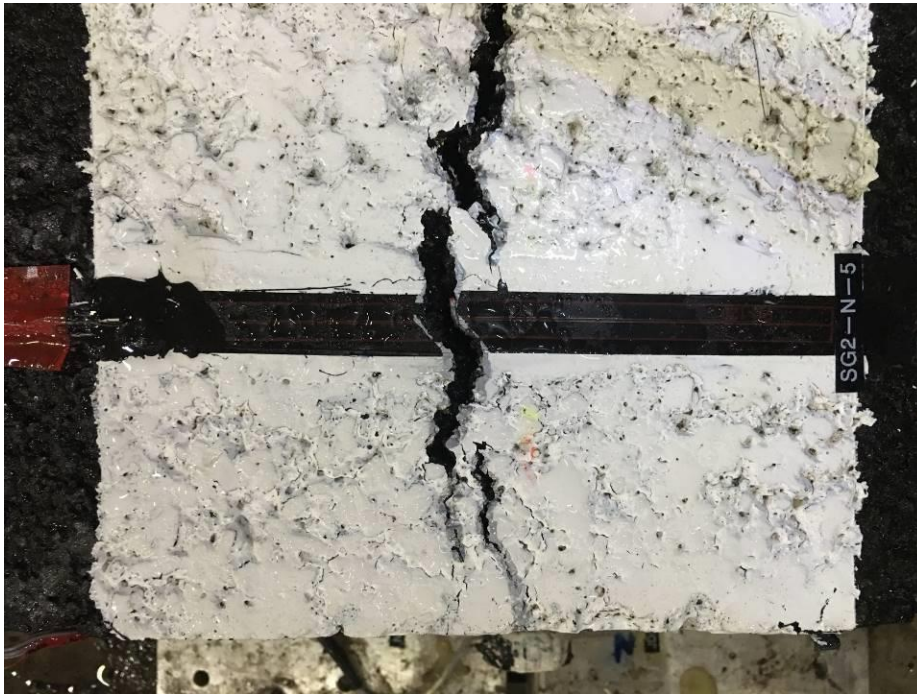
Fig 4 North section surface crack reached inner vertical edge

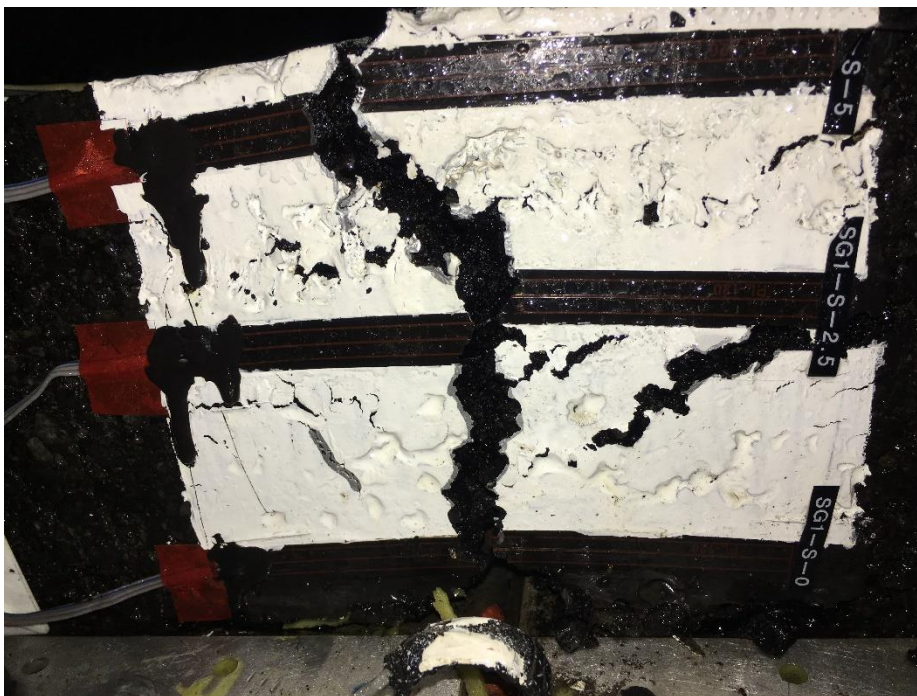
- No change from last observation.
- Bottom up crack at inner vertical edge (Fig5). Bottom up crack at outer vertical edge propagate approximately 0.5 inch resulting SG6-S-2.5 read open (Fig 6).
- Surface crack reached the inner vertical edge (Fig 7), approximately 3.5 inches from the outer vertical edge, no change (Fig 8)

Fig 5 Bottom-up crack at inner vertical edge of south section reached top surface

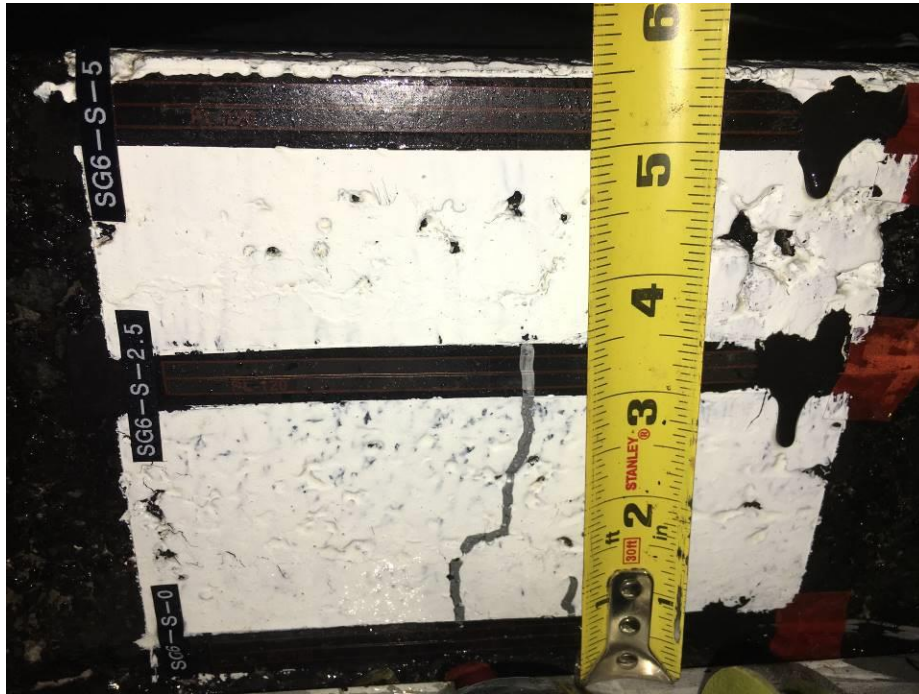
Fig 6 Bottom-up crack at SG6-S-0, SG6-S-2.5 approximately 3.5 inch long

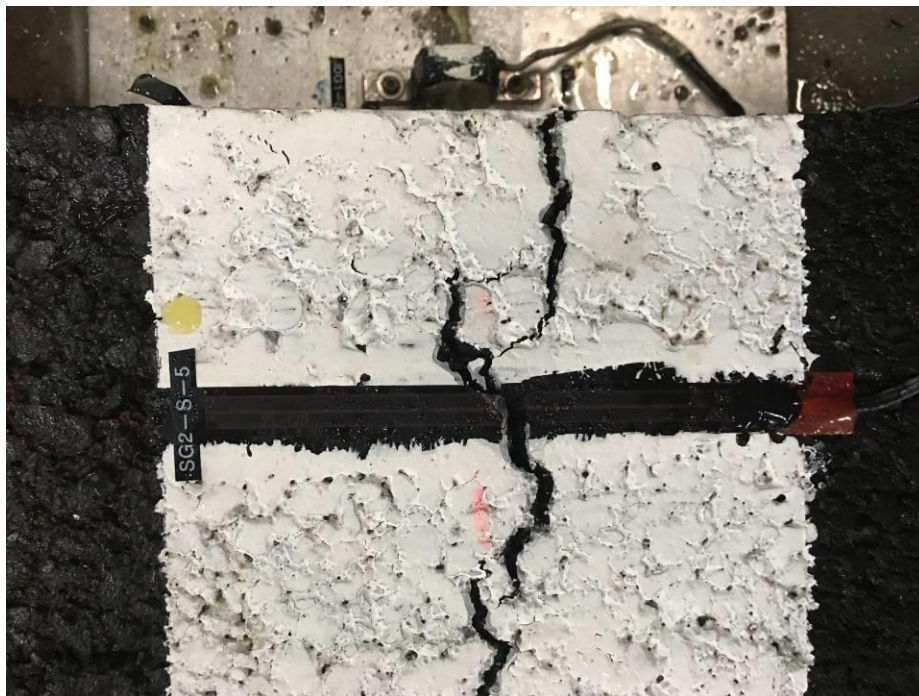
Fig 7 South section surface crack reached the inner vertical edge

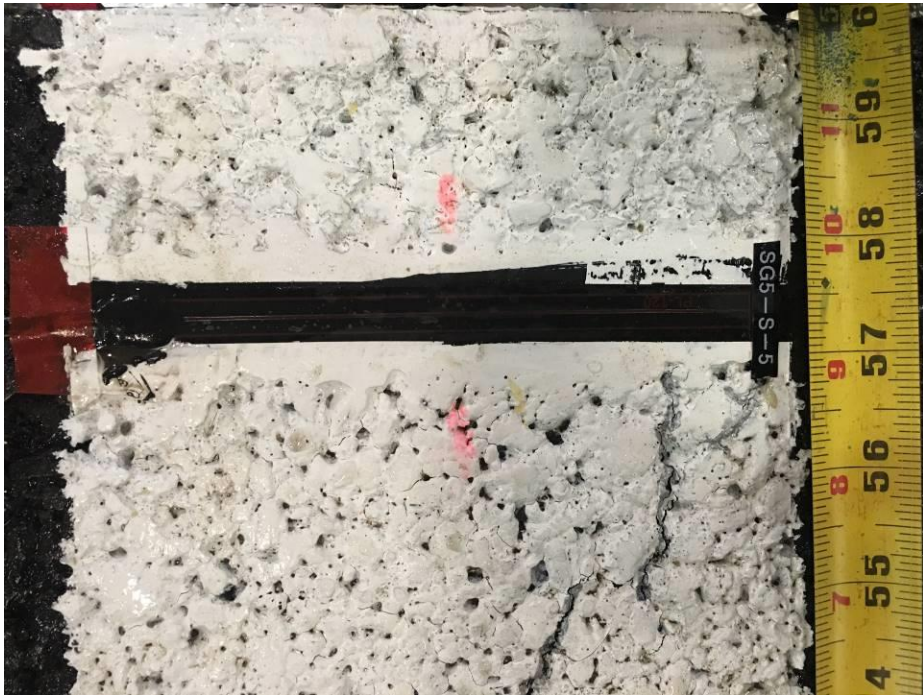
Fig 8 South section surface crack 3 inches from the outer vertical edge

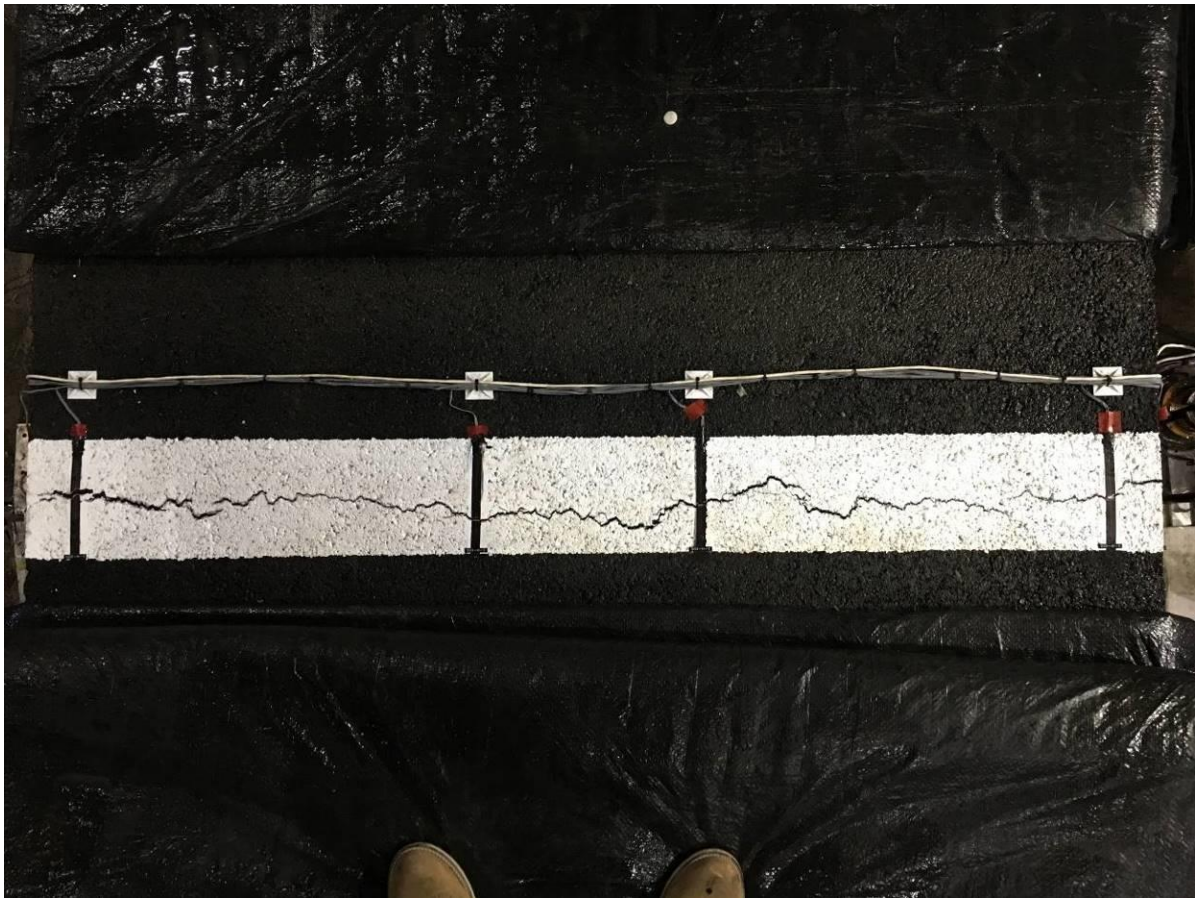
Fig 9 Surface crack on the north section

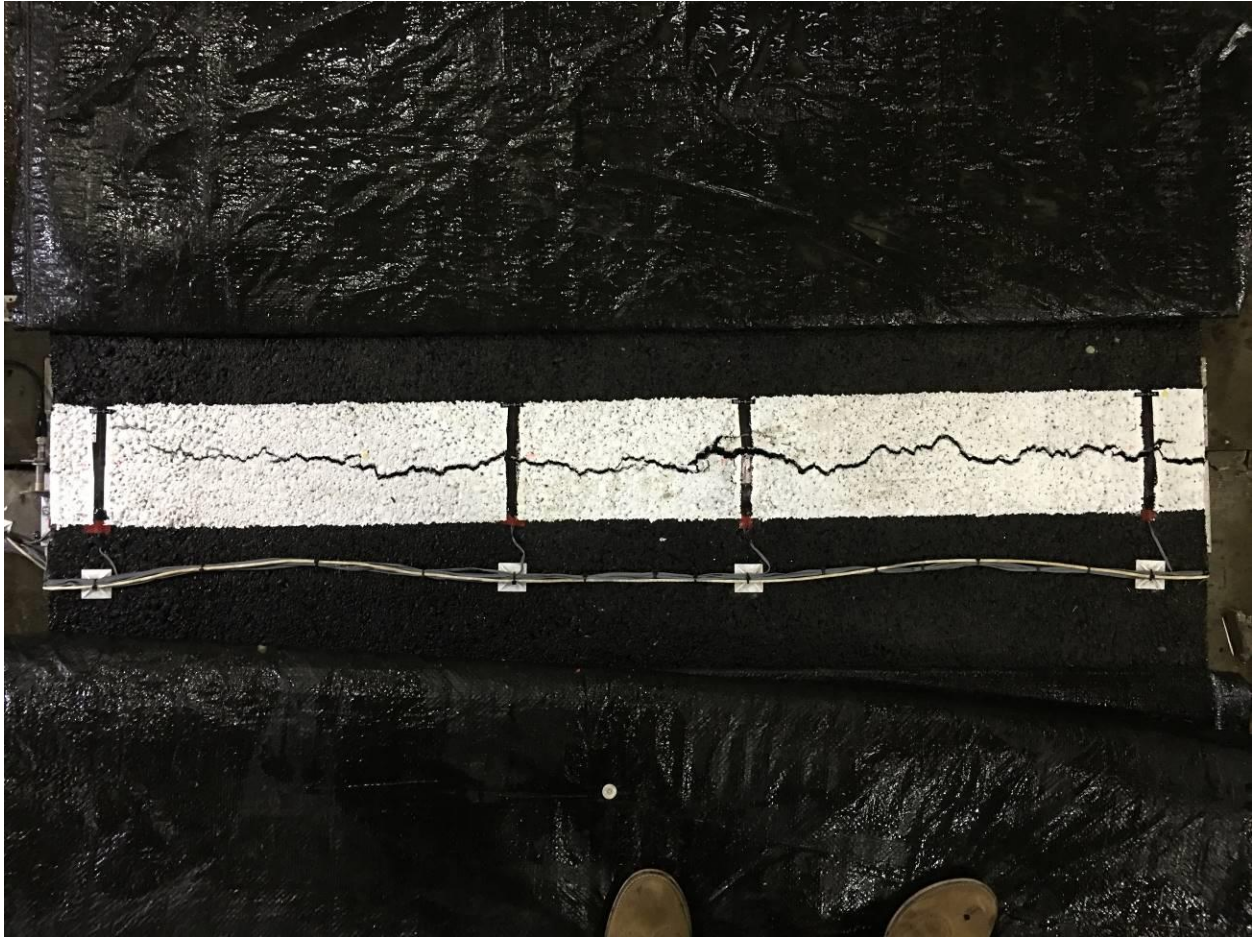
Fig 10 Surface crack on the south section
