## DO15 RC Indoor Phase VI Test Daily Notes

*Date: August 05, 2019*

*Cycle count: 6389*

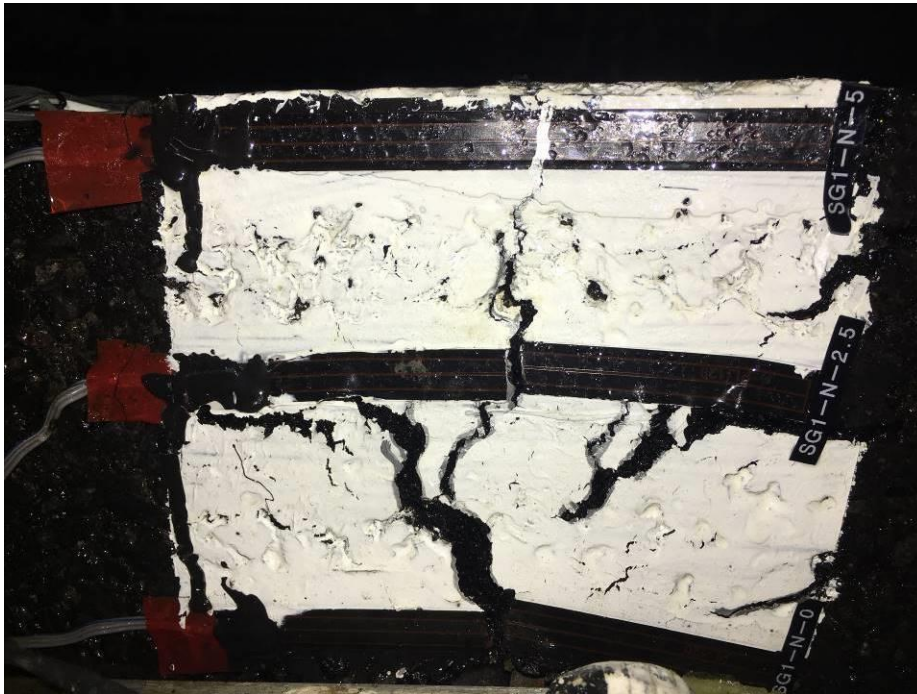
- Completed cracked, no further change.
- Bottom up crack at inner vertical edge as seen in Fig 1. Bottom up crack at outer vertical edge as seen in Fig 2.
- Surface crack connected to the bottom-up crack of the outer edge as seen in Fig 3, and the inner vertical edge shown in Fig 4.

Fig 1 Bottom-up crack at north section inner vertical edge reached top surface

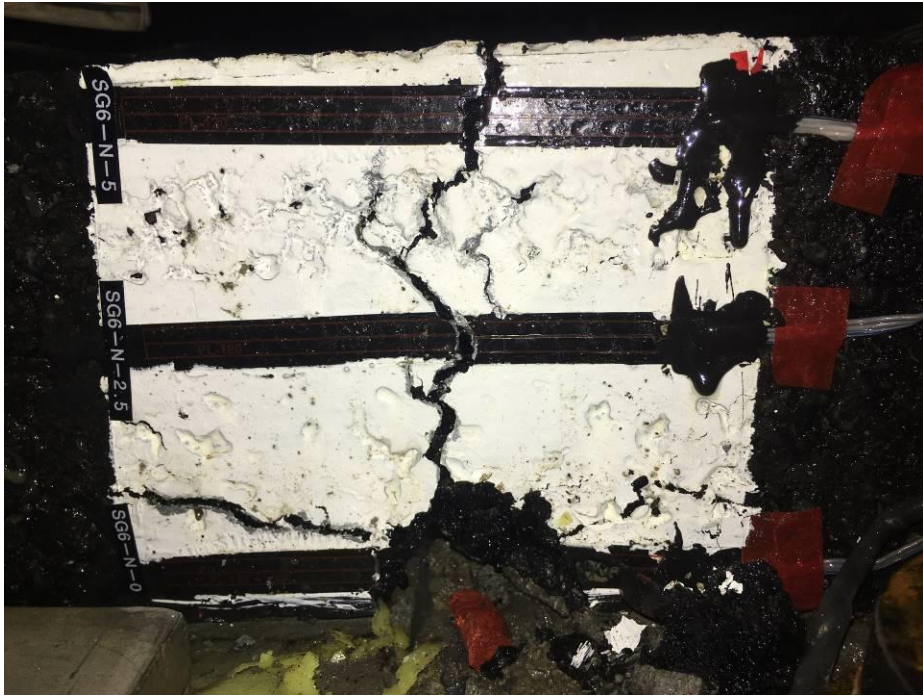
Fig 2 Bottom-up crack at north section outer edge reached top surface

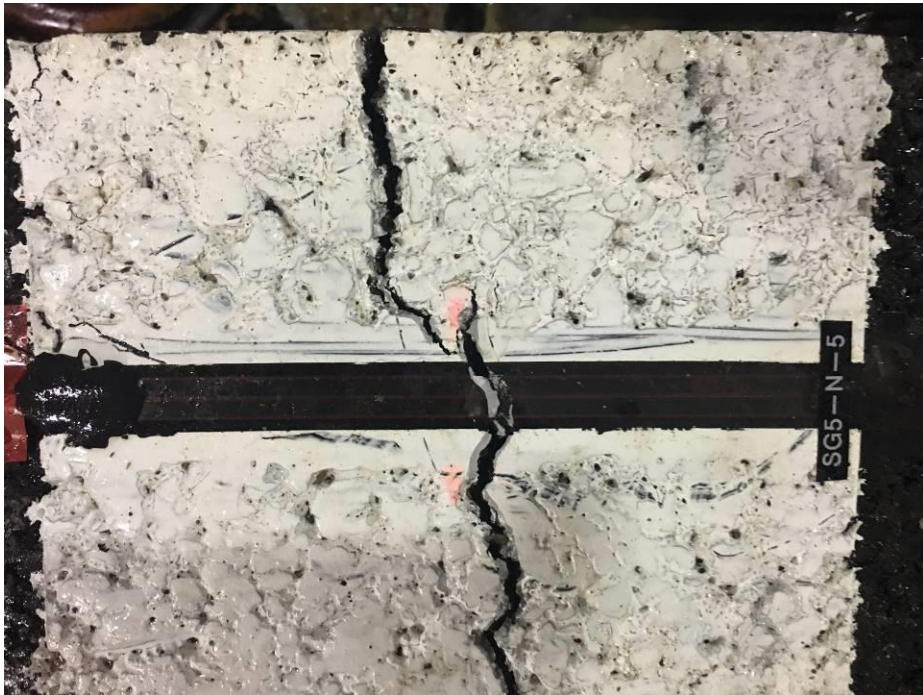
Fig 3 Surface crack on North Section reached outer edge

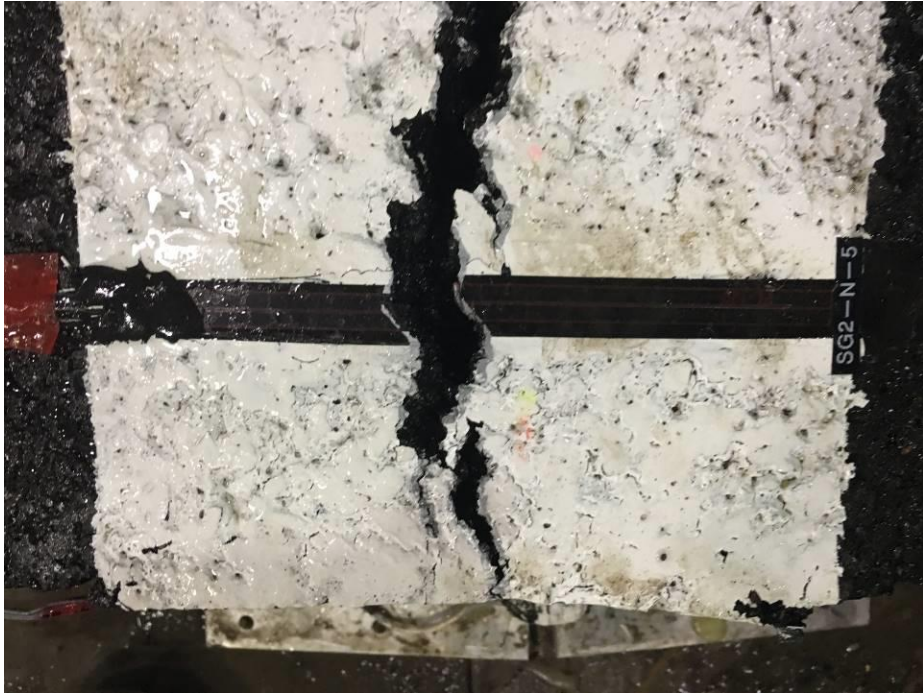
Fig 4 North section surface crack reached inner vertical edge

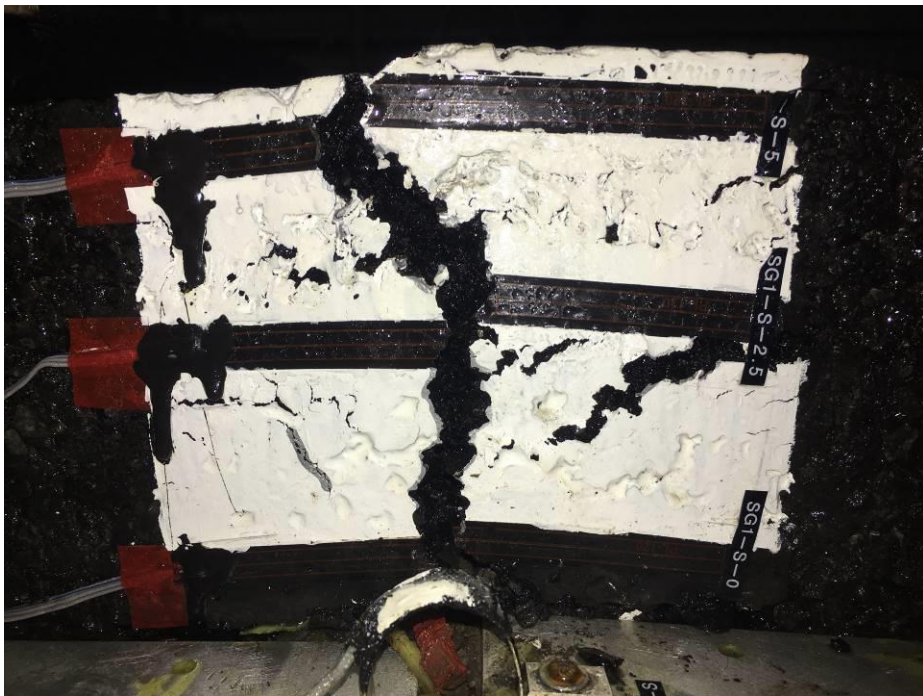
- No change from last observation.
- Bottom up crack at inner vertical edge shown in Fig5. Bottom up crack at outer vertical edge measured approximately 3.5 inch as shown in Fig 6.
- Surface crack reached the inner vertical edge as shown in Fig 7, approximately 3 inches from the outer vertical edge, no change as seen in Fig 8.

Fig 5 Bottom-up crack at inner vertical edge of south section reached top surface

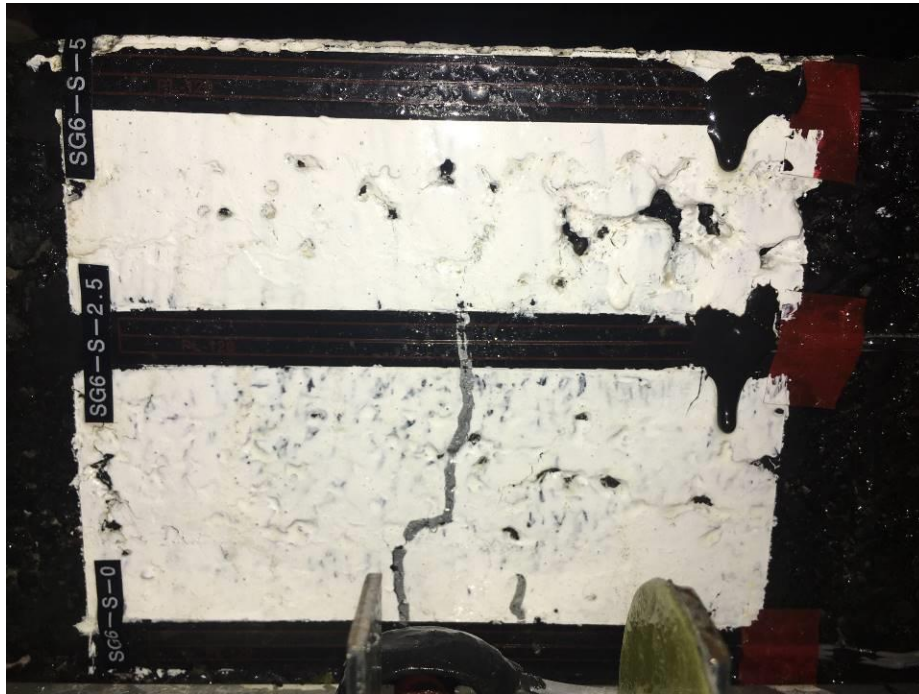
Fig 6 Bottom-up crack at SG6-S-0, SG6-S-2.5 approximately 3.5 inch long

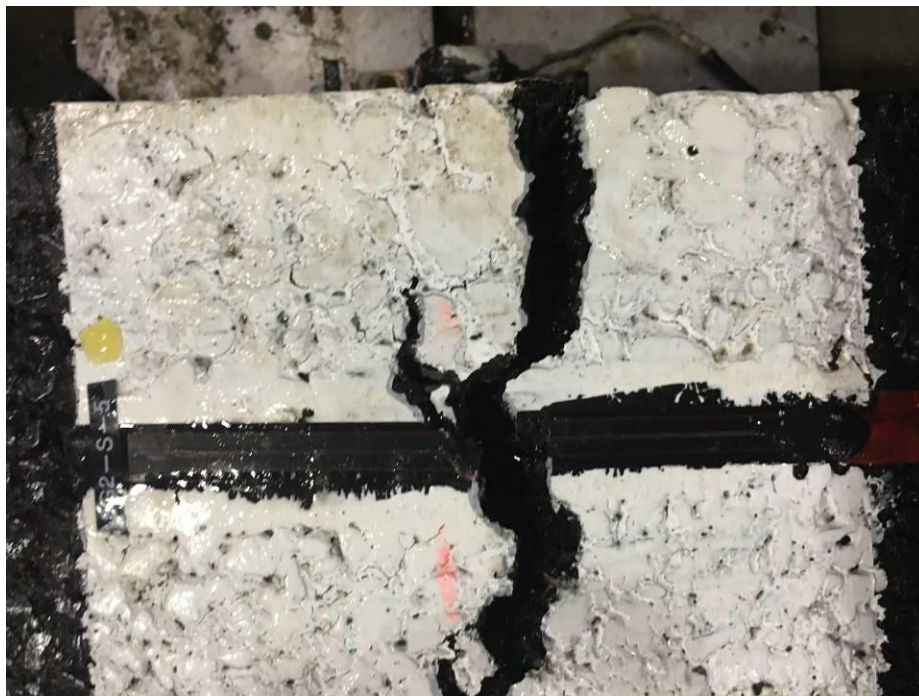
Fig 7 South section surface crack reached the inner vertical edge

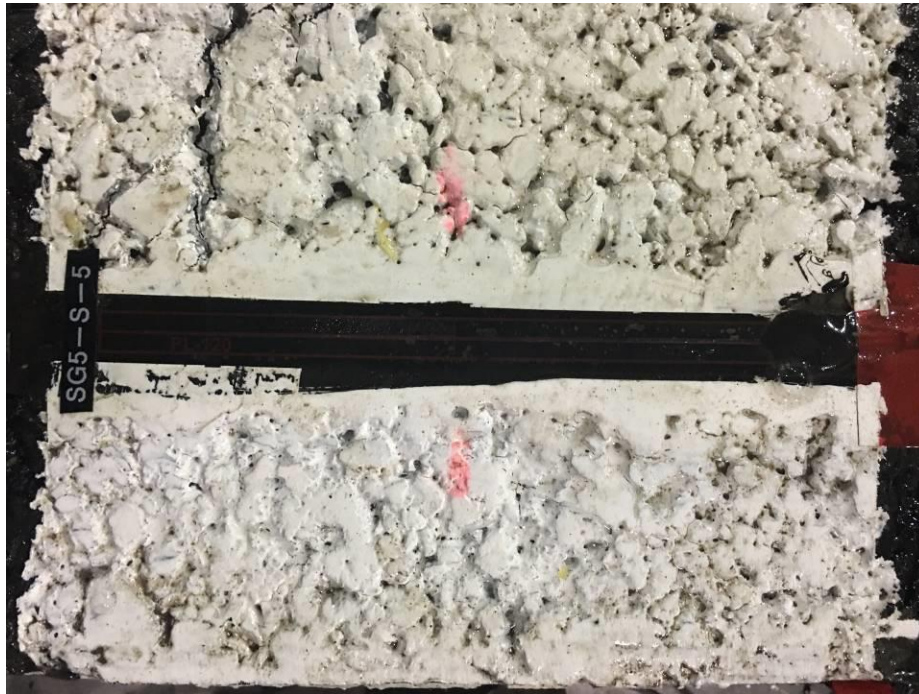
Fig 8 South section surface crack 3 inches from the outer vertical edge

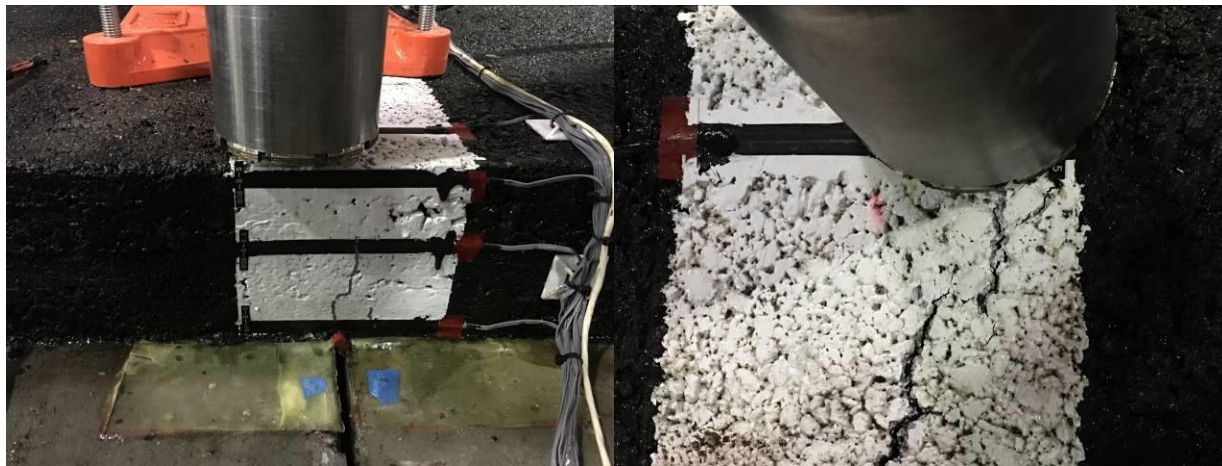
The RC Indoor Phase VI test was completed today (Aug 05, 2019). At 2:00PM, one overlay core was taken at the outer edge of the south section as shown in the following Figs. At 3:00PM, the chiller, rig and the DAQ were shut off.

Figure 9 Overlay core taken at the outer edge of south section

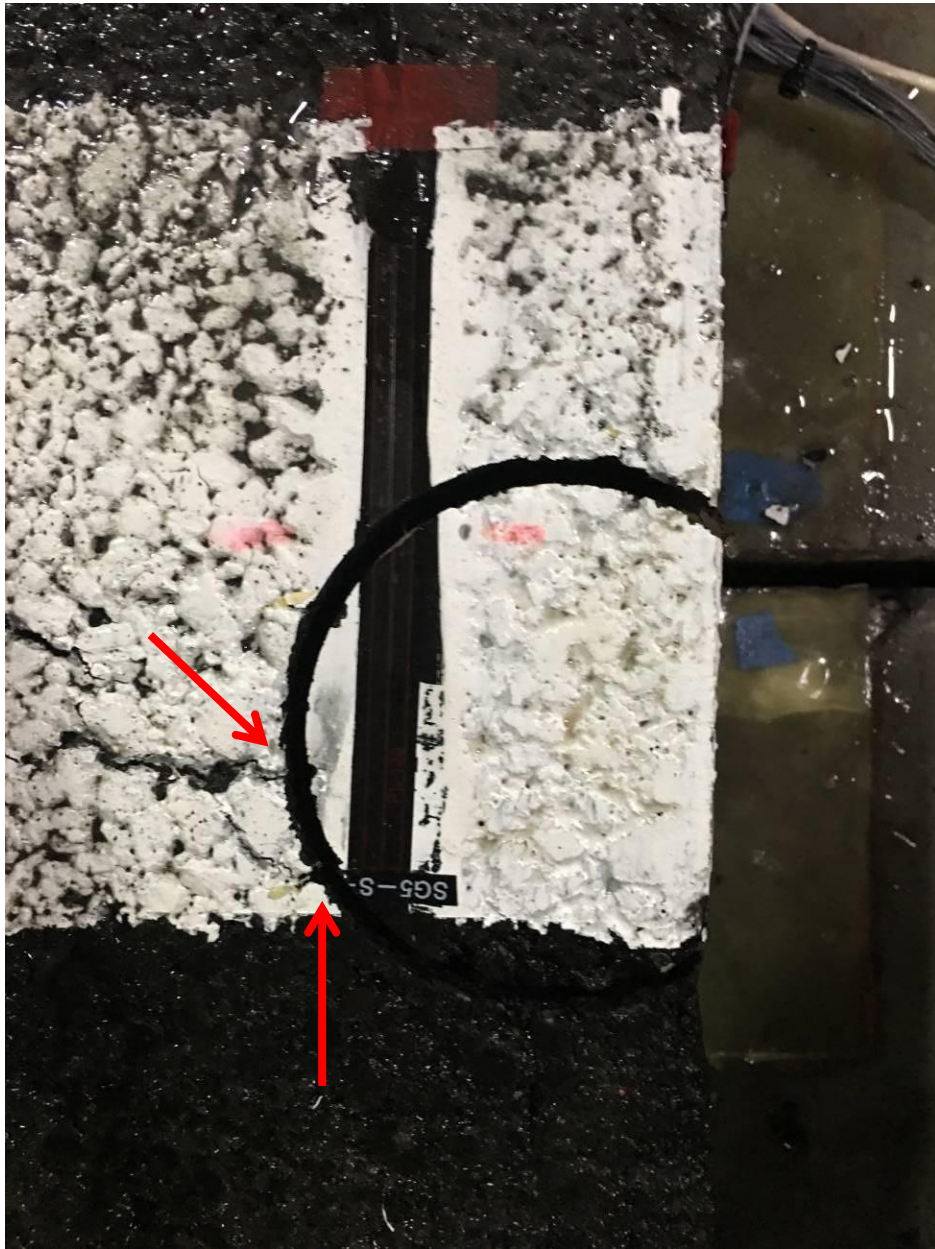
Figure 10 Overlay core taken at the end of the surface crack

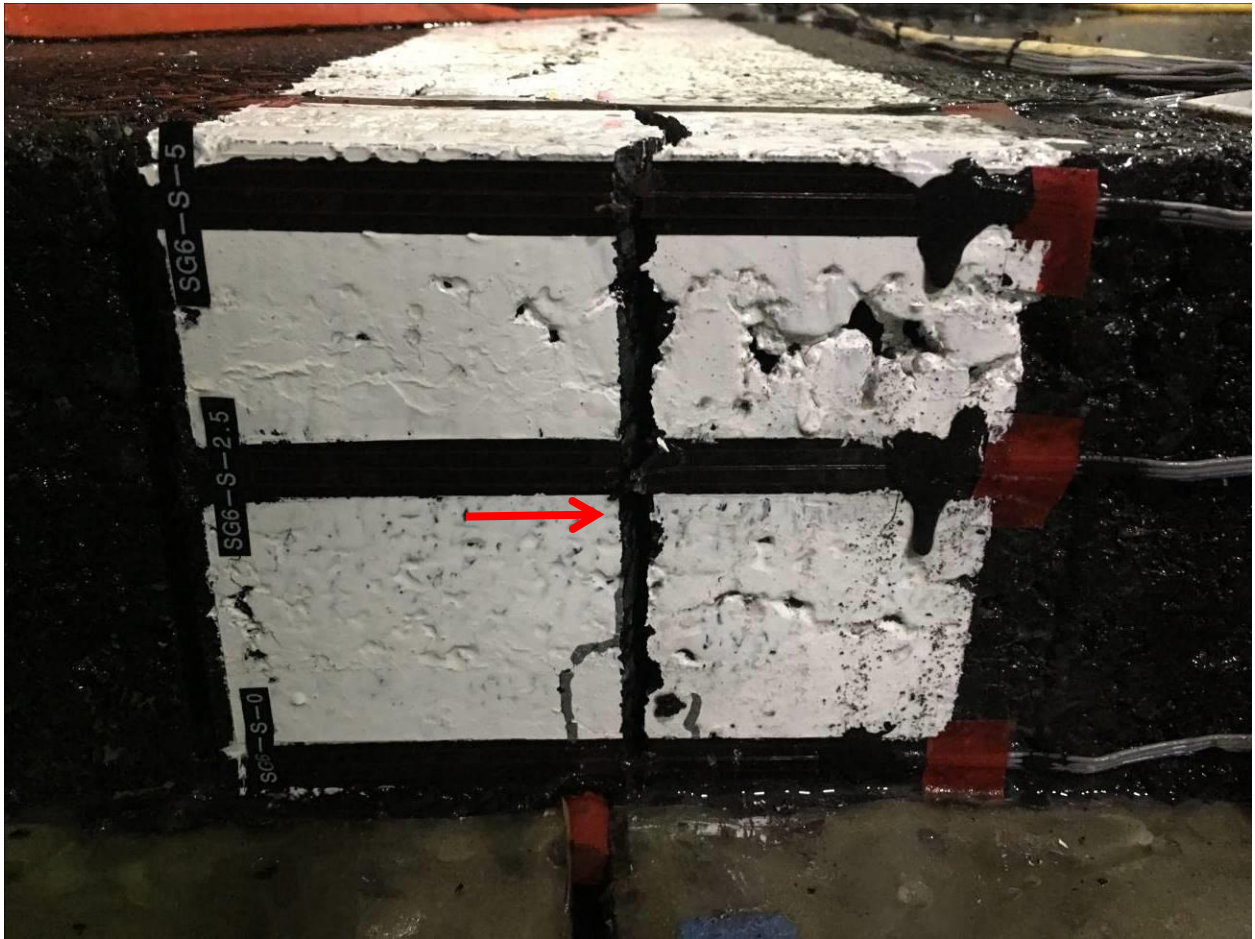
Figure 11 Overlay core taken at the bottom up crack
