## DO15 RC Indoor Phase VI Test Daily Notes

*Date: June 17, 2019*

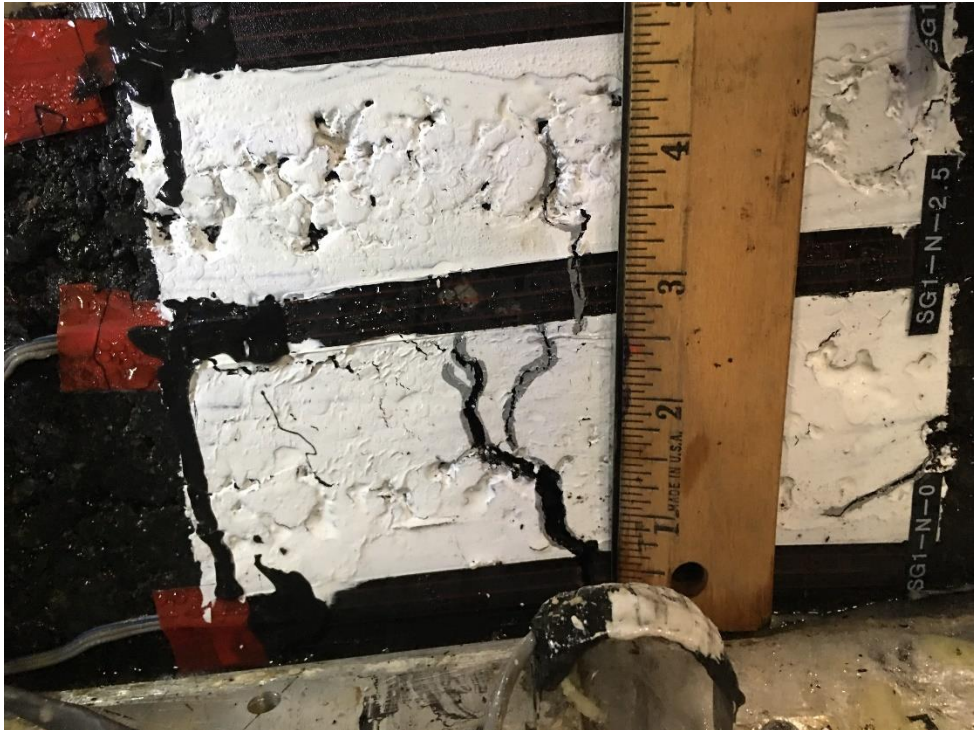
Fig 1 Bottom-up crack at SG1-N-0 and SG1-N-2.5 4.25 inch long

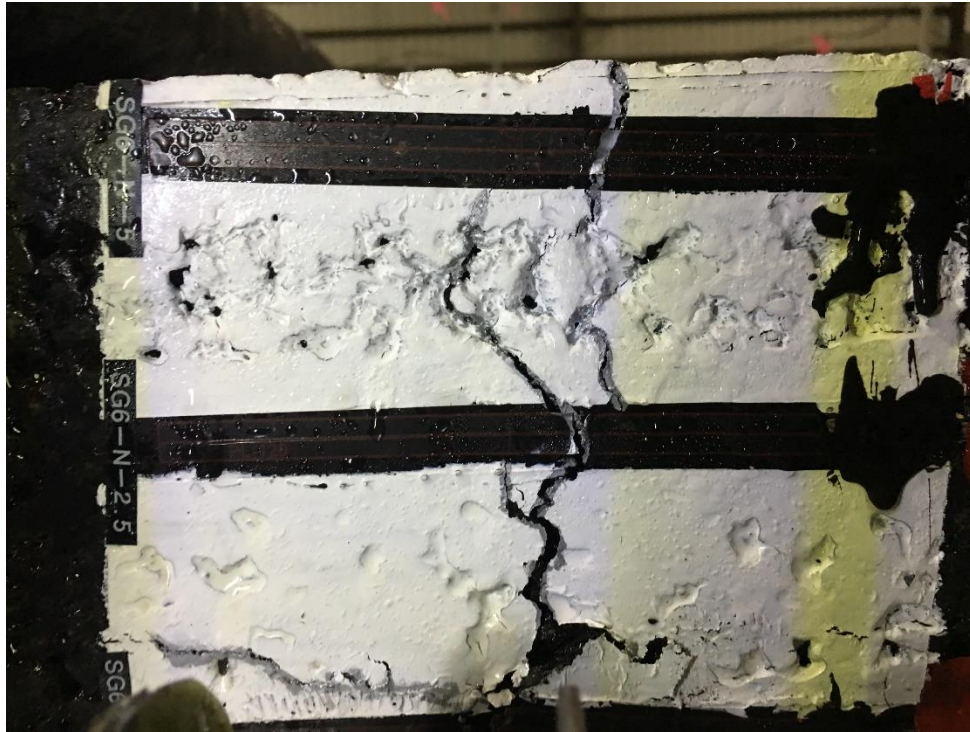
Fig 2 Bottom-up crack north outer edge reached top surface

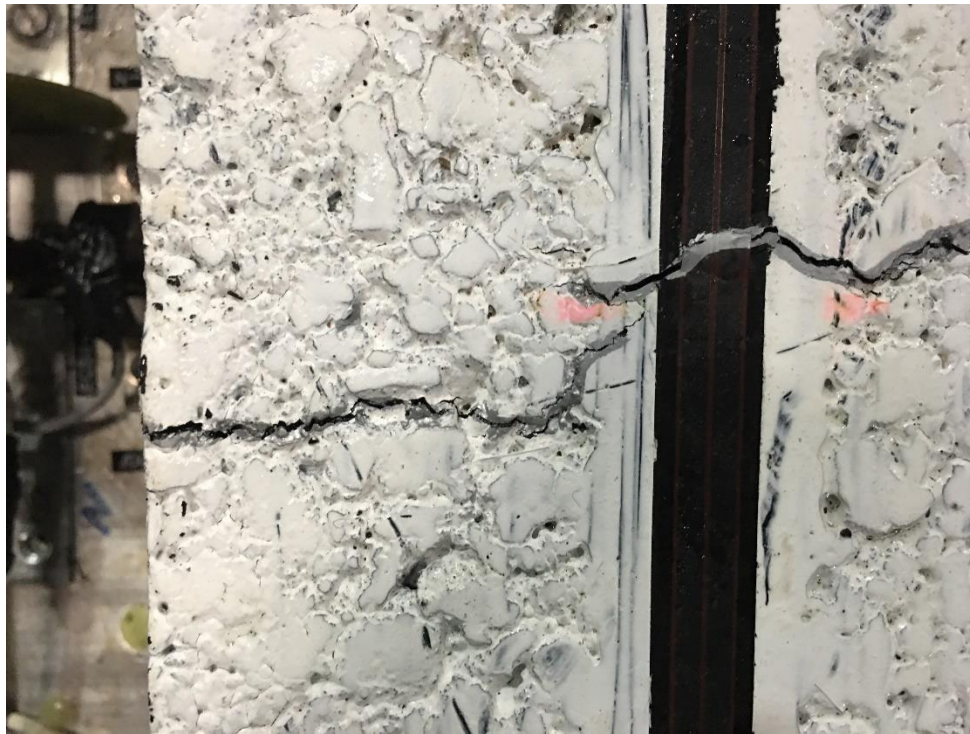
Fig 3 Surface crack on North Section reached outer edge

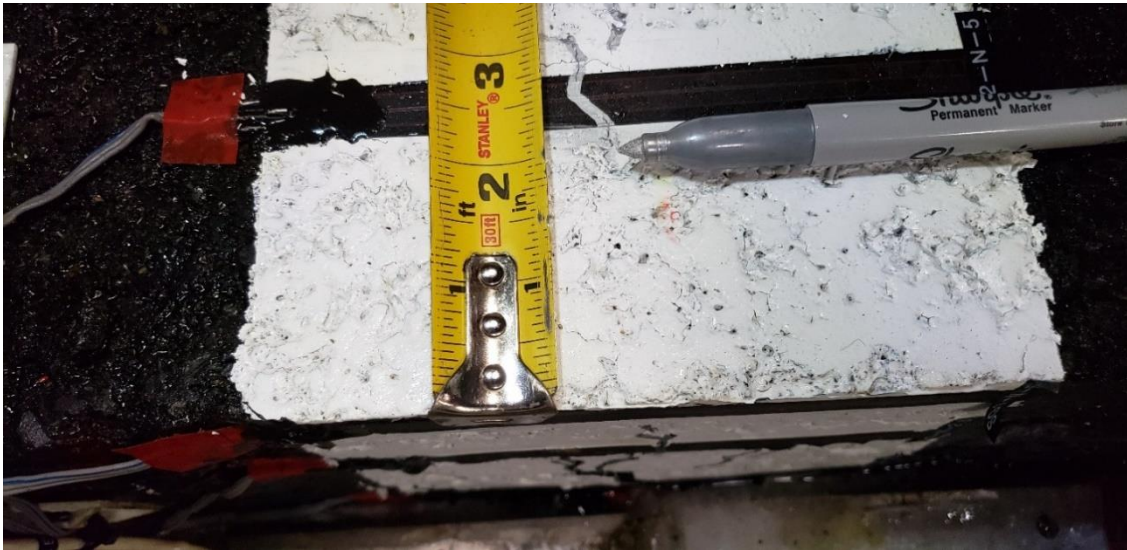
Fig 4 North section surface crack 2 inch from the inner vertical edge

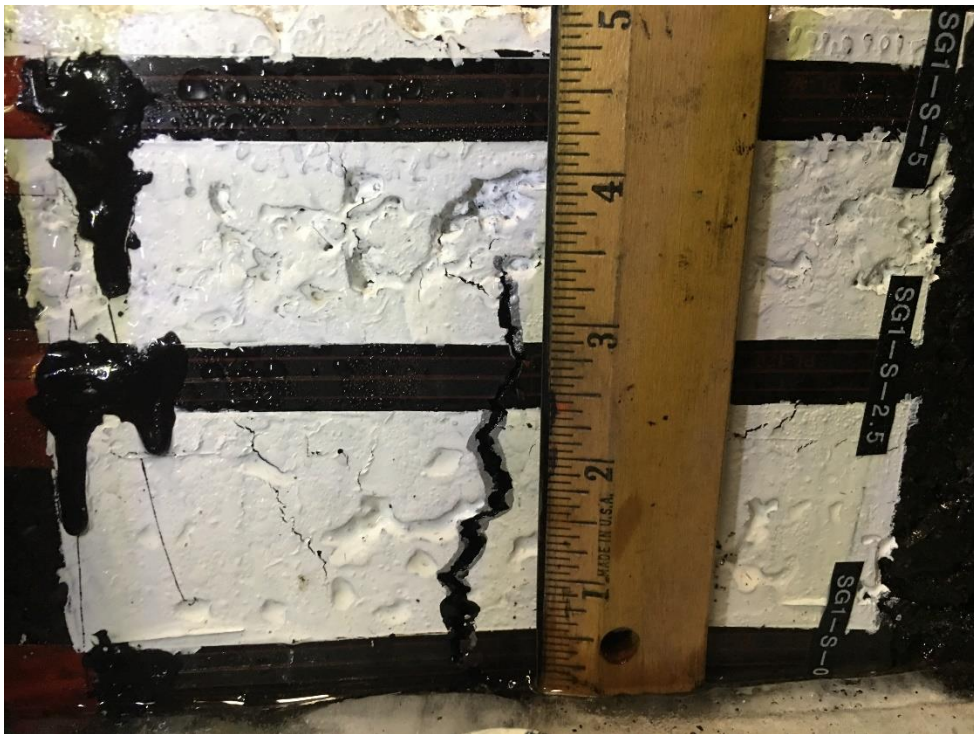
Fig 4 Bottom-up crack at SG1-S-0 3.5 inch long

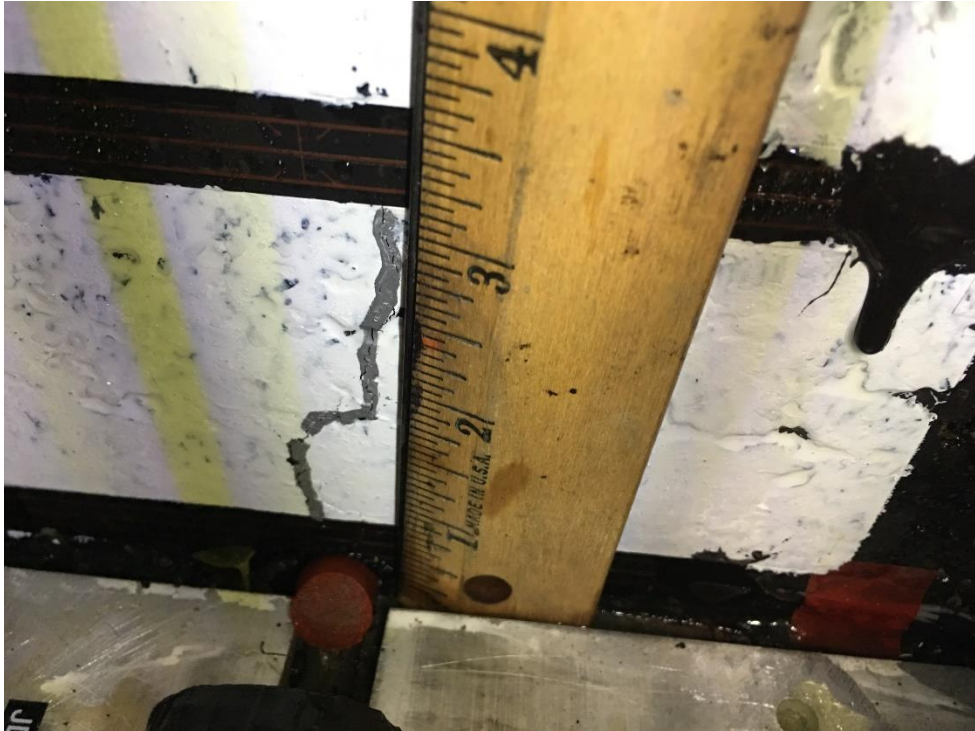
Fig 5 Bottom-up crack at SG6-S-0 3 inch long

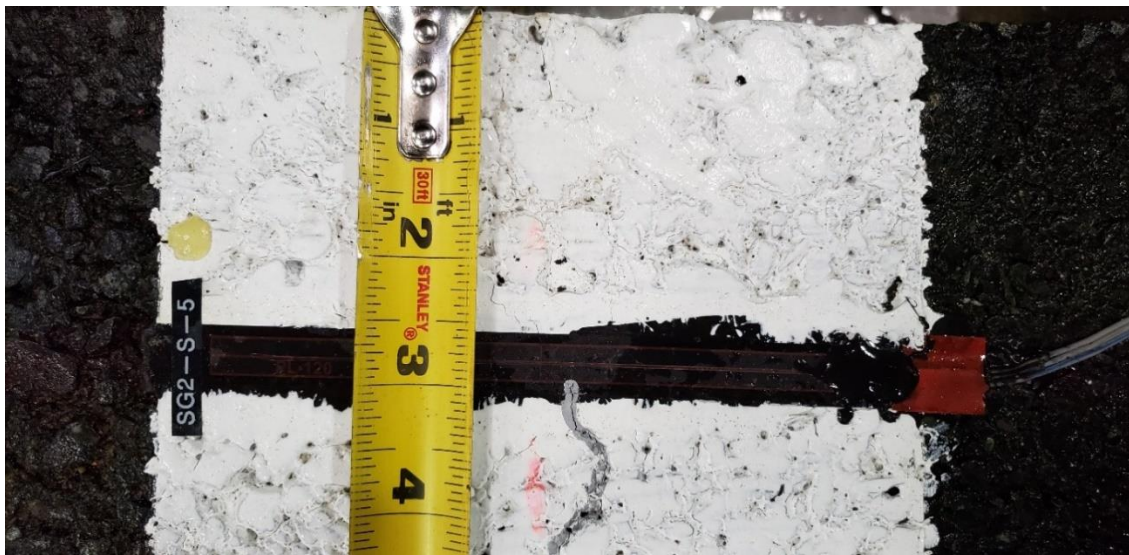
Fig 6 South section surface crack 3 inches from the inner vertical edge

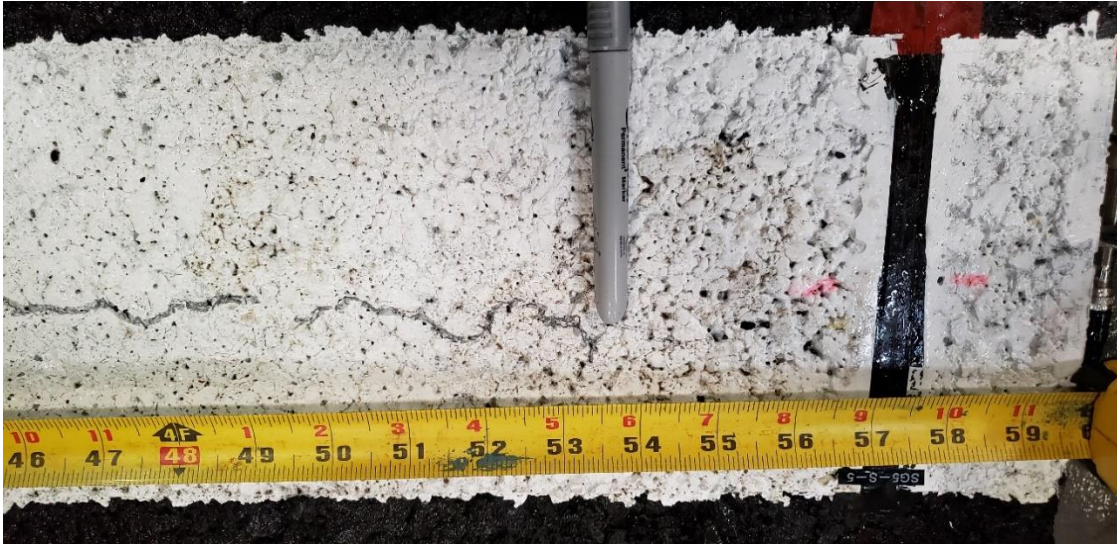
Fig 7 South section surface crack 6 inches from the outer vertical edge
