DO15 RC Indoor Phase VI Test Daily Notes

Date: June 26, 2019

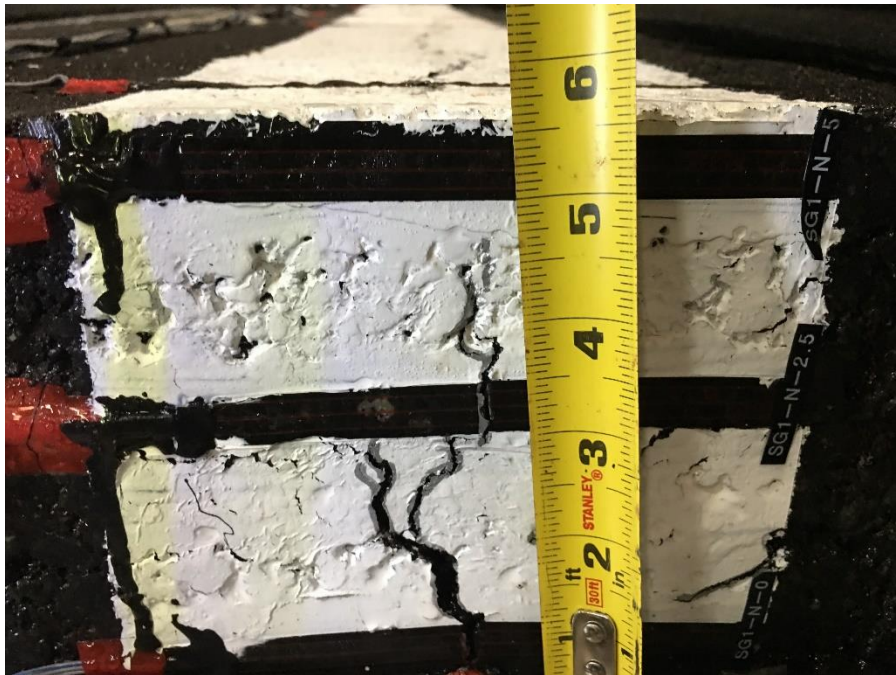
- 1 crack through SG1-N-0 and SG1-N-2.5 approximately 4.5 inches, no change (Fig 1).
- 1 crack through SG6-N-0, SG6-N-2.5 and SG6-N-5 all the way to the top surface (Fig 2).
- Surface crack connected to the bottom-up crack of the outer edge (Fig 3), 1.5 inch from the inner vertical edge, no change (Fig 4).

Fig 1 Bottom-up crack at SG1-N-0 and SG1-N-2.5 4.5 inch long

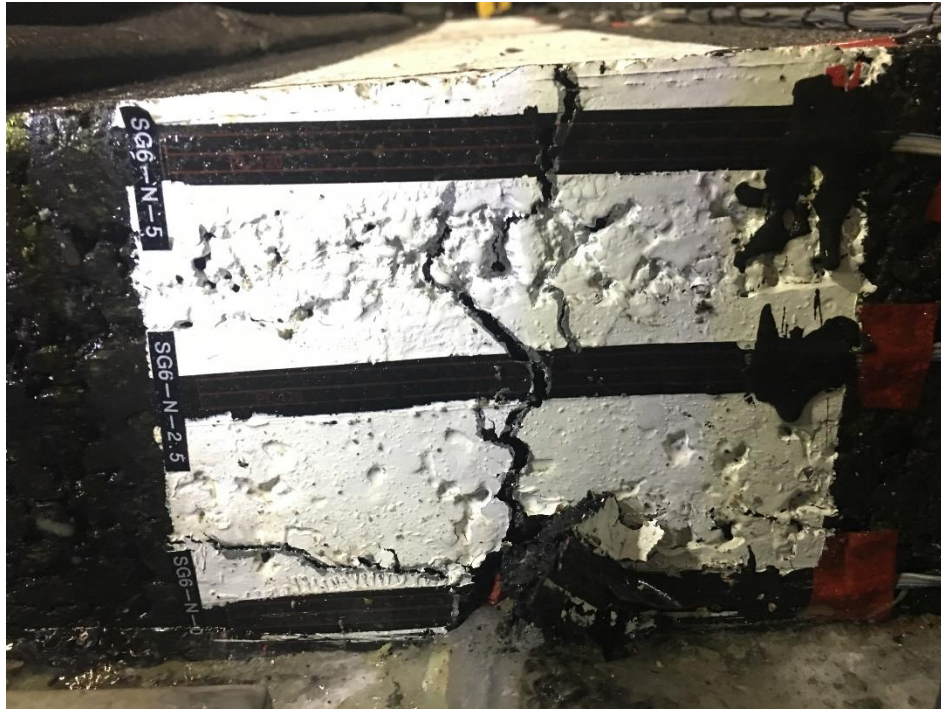
Fig 2 Bottom-up crack north outer edge reached top surface

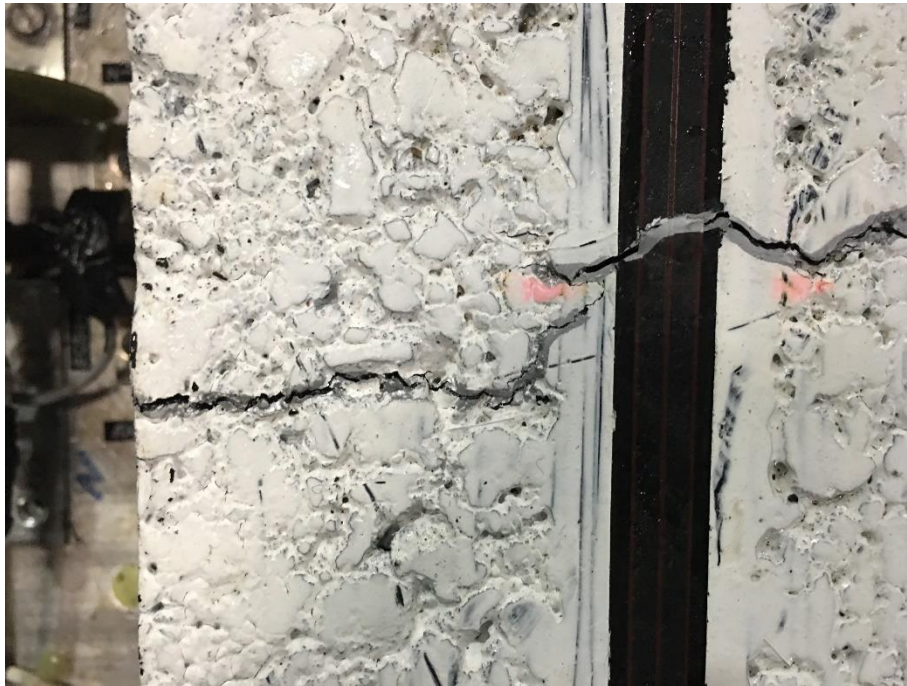
Fig 3 Surface crack on North Section reached outer edge

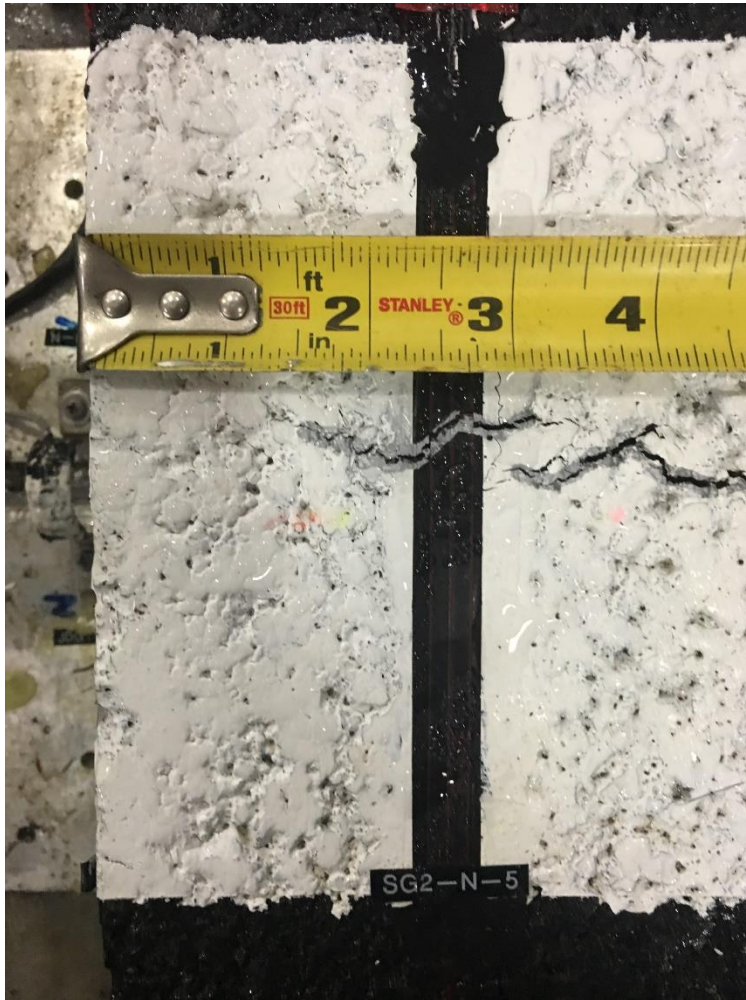
Fig 4 North section surface crack 1.5 inch from the inner vertical edge

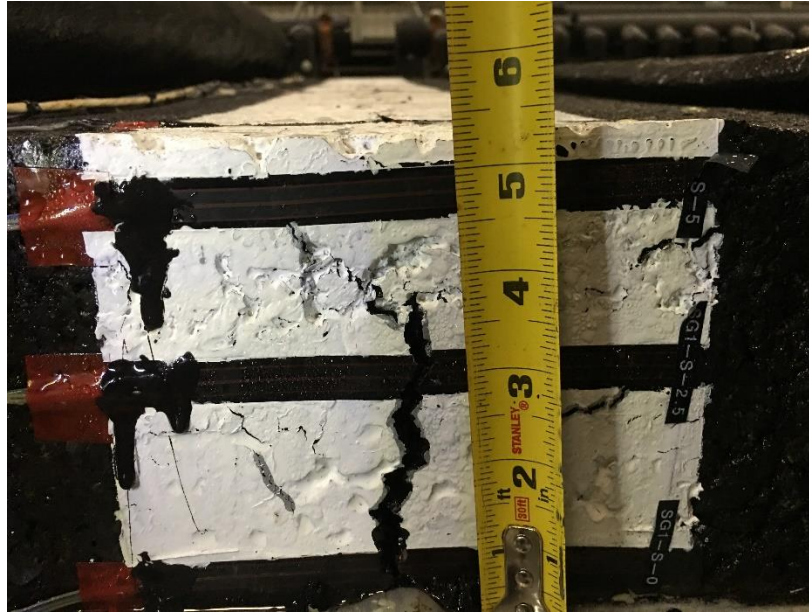
- 1 crack through SG1-S-0, approximately 4.5 inches (Fig 5).
- 1 crack through SG6-S-0, approximately 3 inches, no change (Fig 6).
- Surface crack is 1.0 inch from the inner vertical edge (Fig 7), approximately 3 inches from the outer vertical edge (Fig 8)

Fig 5 Bottom-up crack at SG1-S-0 4.5 inch long

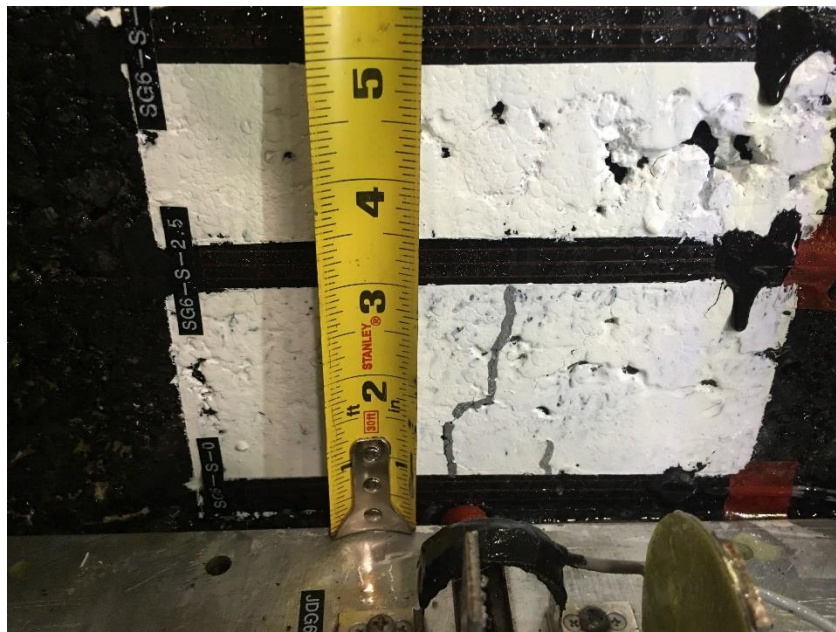
Fig 6 Bottom-up crack at SG6-S-0 3 inch long

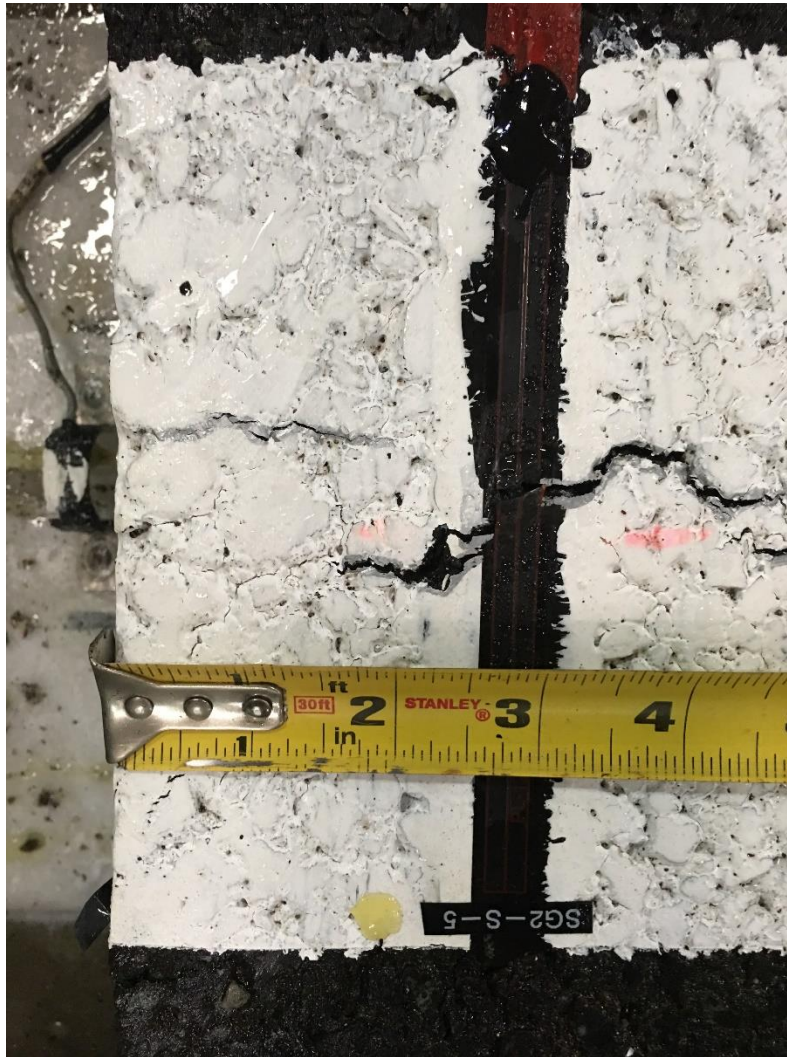
Fig 7 South section surface crack 1 inches from the inner vertical edge

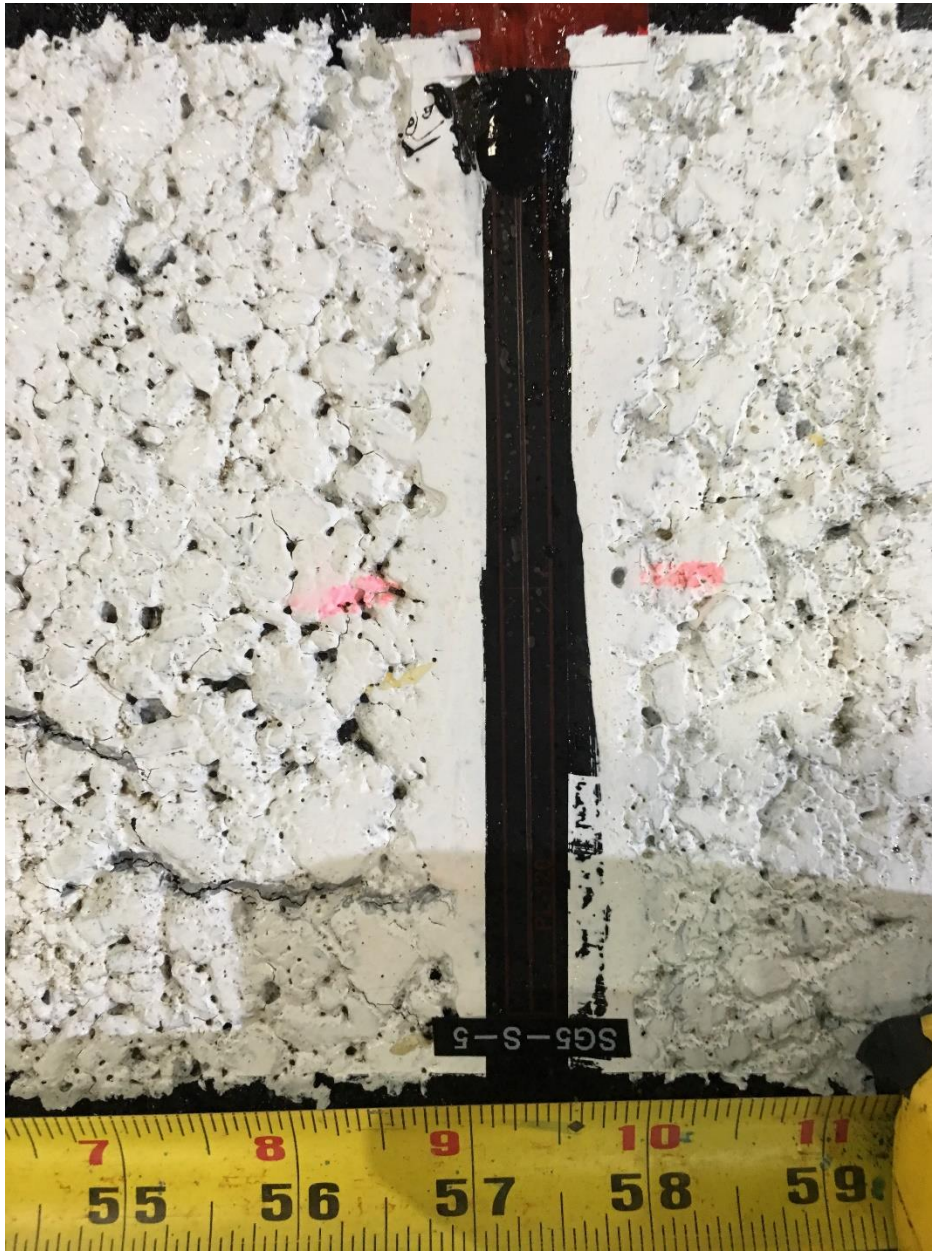
Fig 8 South section surface crack 3 inches from the outer vertical edge
