## DO15 RC Indoor Phase VI Test Daily Notes

*Date: July 15, 2019*

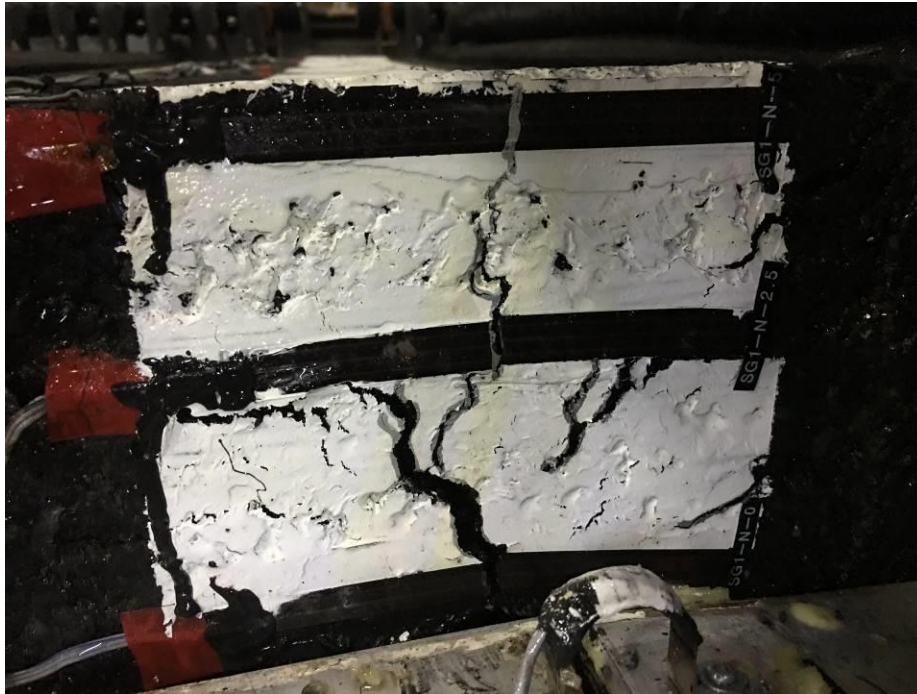
Fig 1 Bottom-up crack at north section inner vertical edge reached top surface

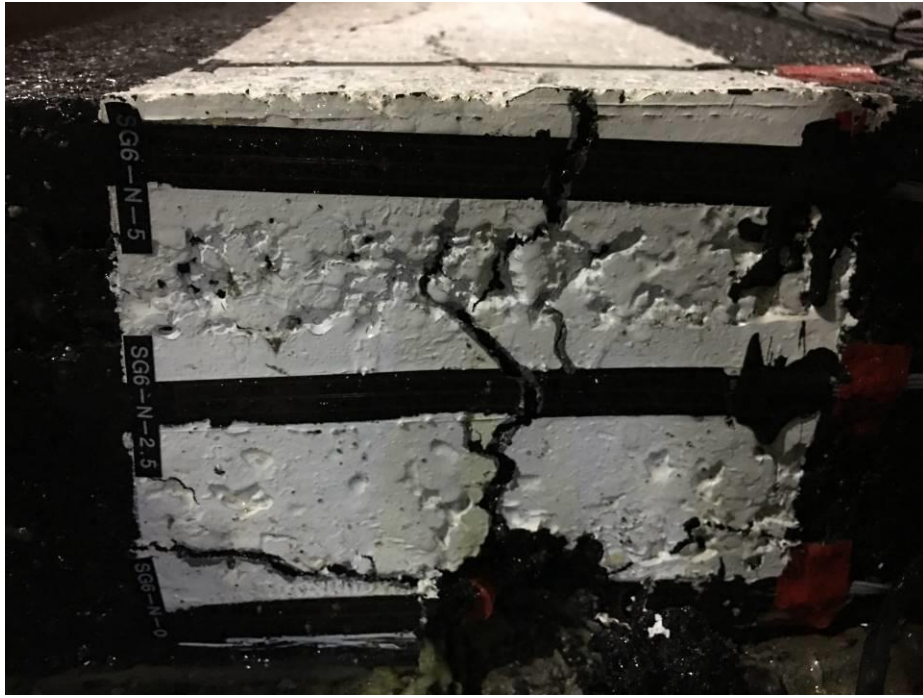
Fig 2 Bottom-up crack at north section outer edge reached top surface

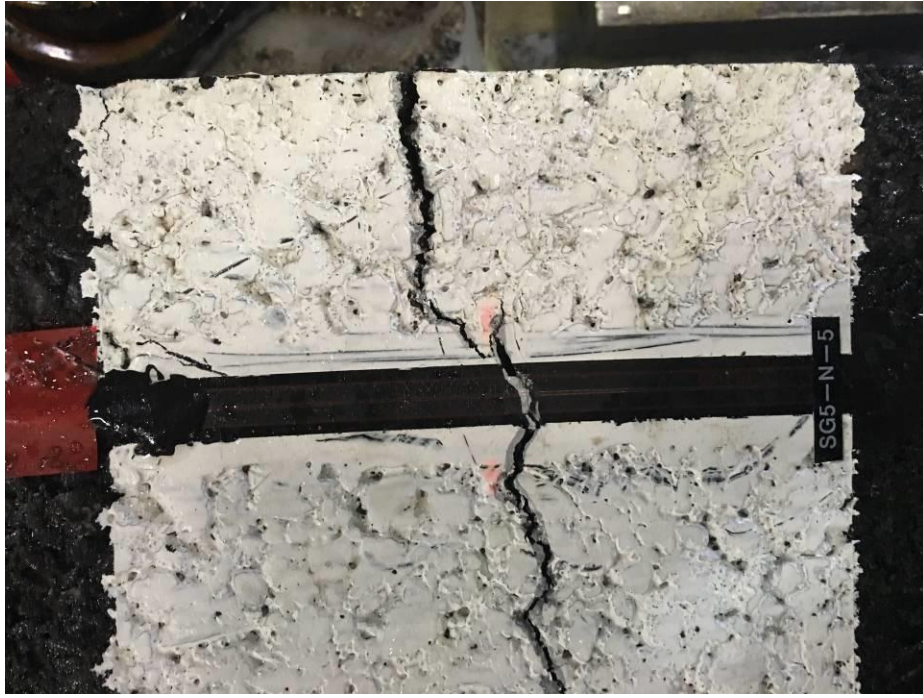
Fig 3 Surface crack on North Section reached outer edge

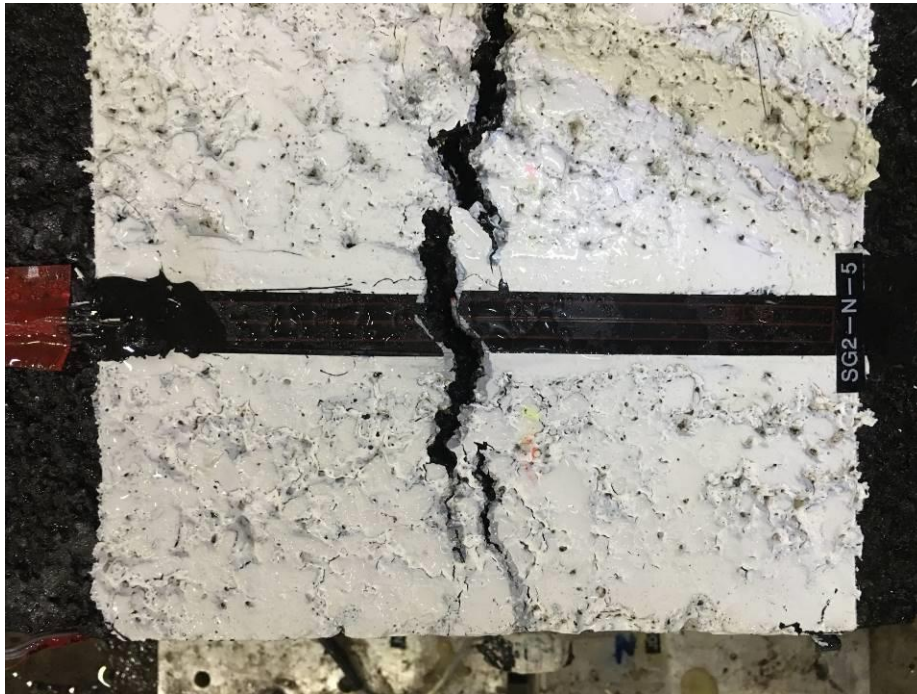
Fig 4 North section surface crack reached inner vertical edge

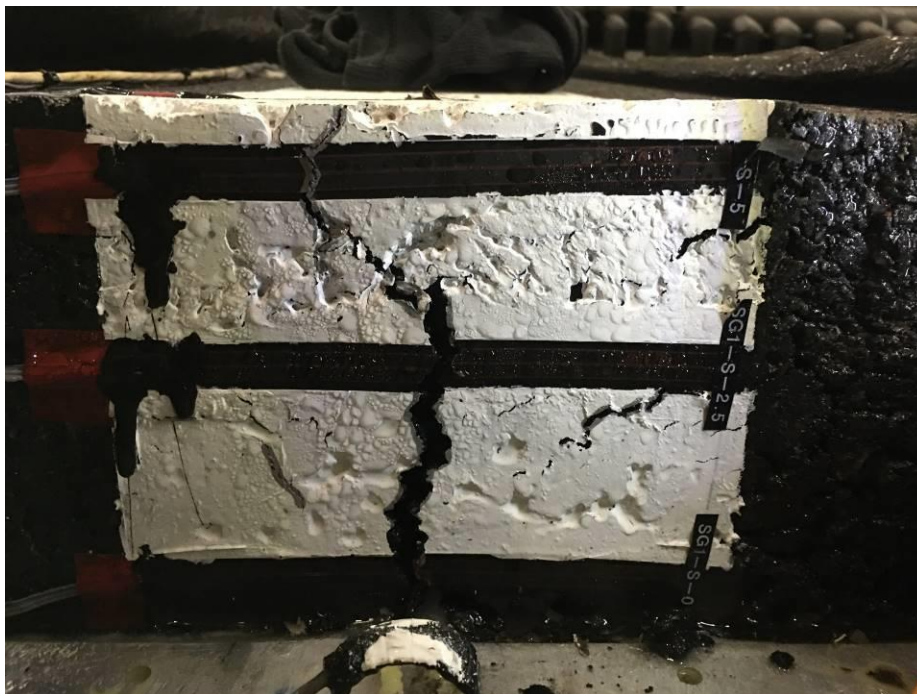
Fig 5 Bottom-up crack at inner vertical edge of south section reached top surface

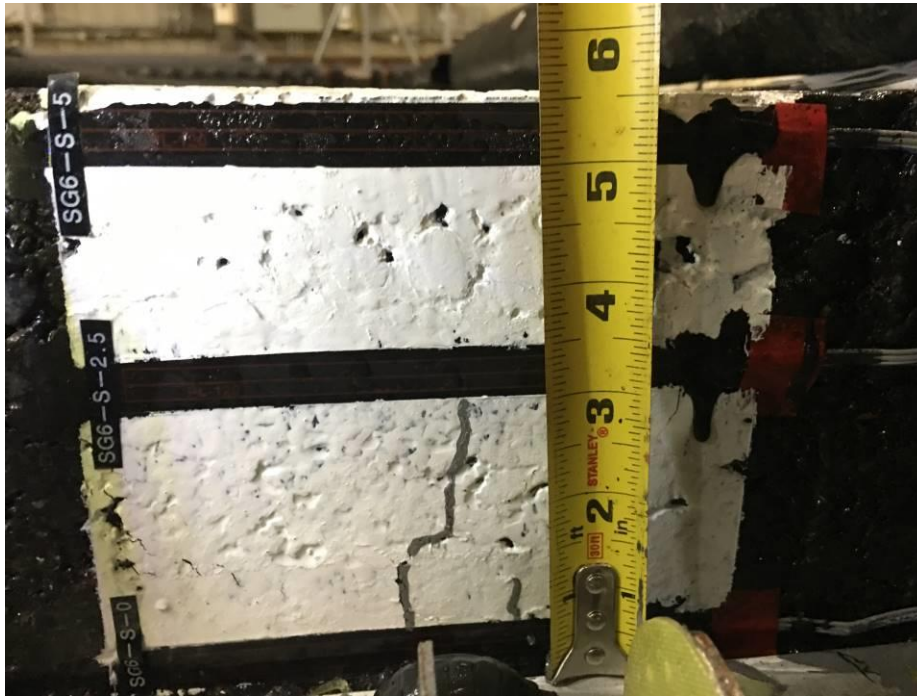
Fig 6 Bottom-up crack at SG6-S-0 3 inch long

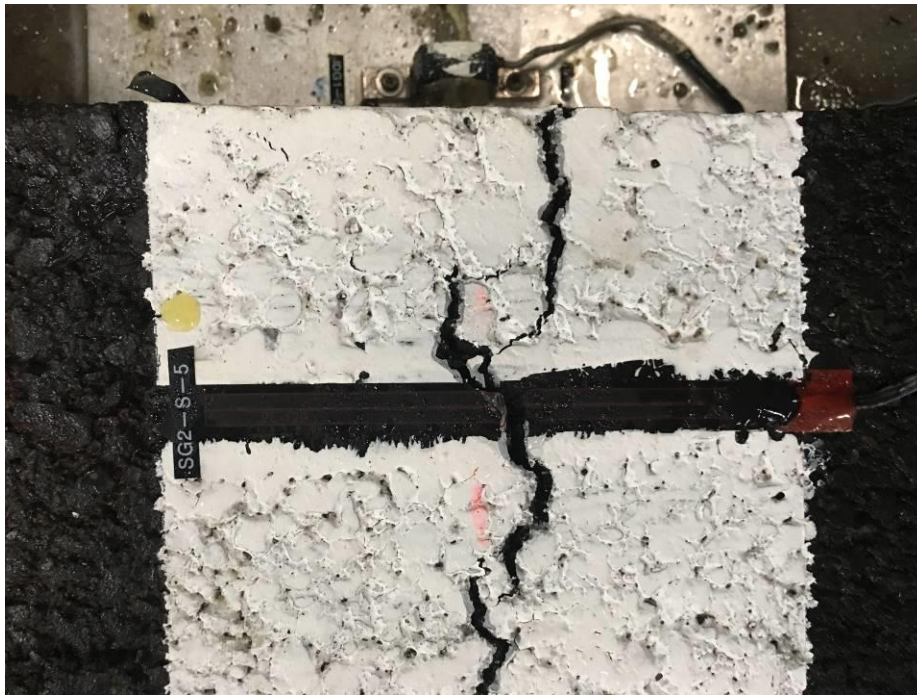
Fig 7 South section surface crack reached the inner vertical edge

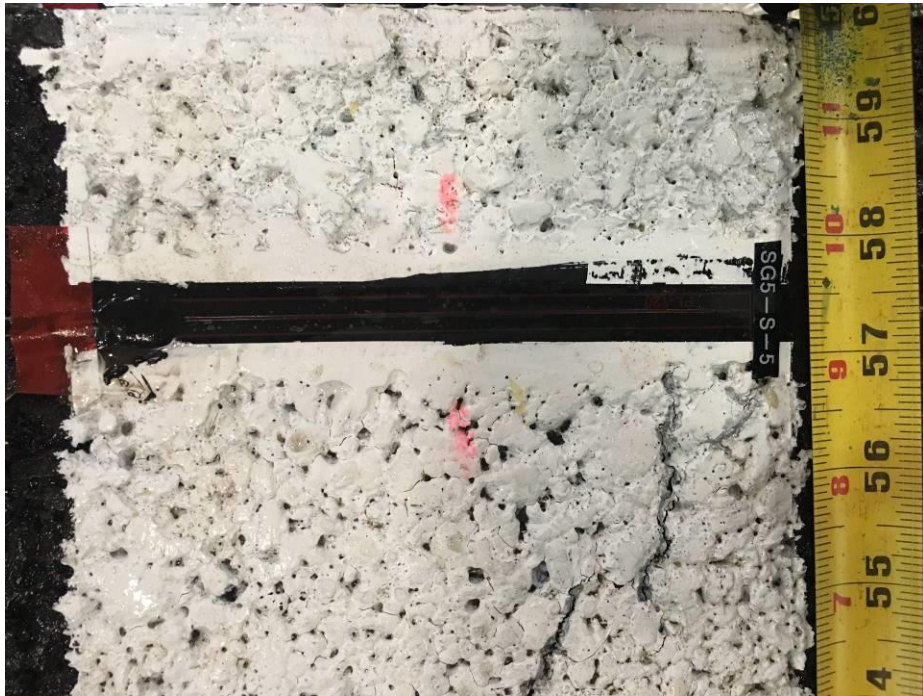
Fig 8 South section surface crack 3 inches from the outer vertical edge

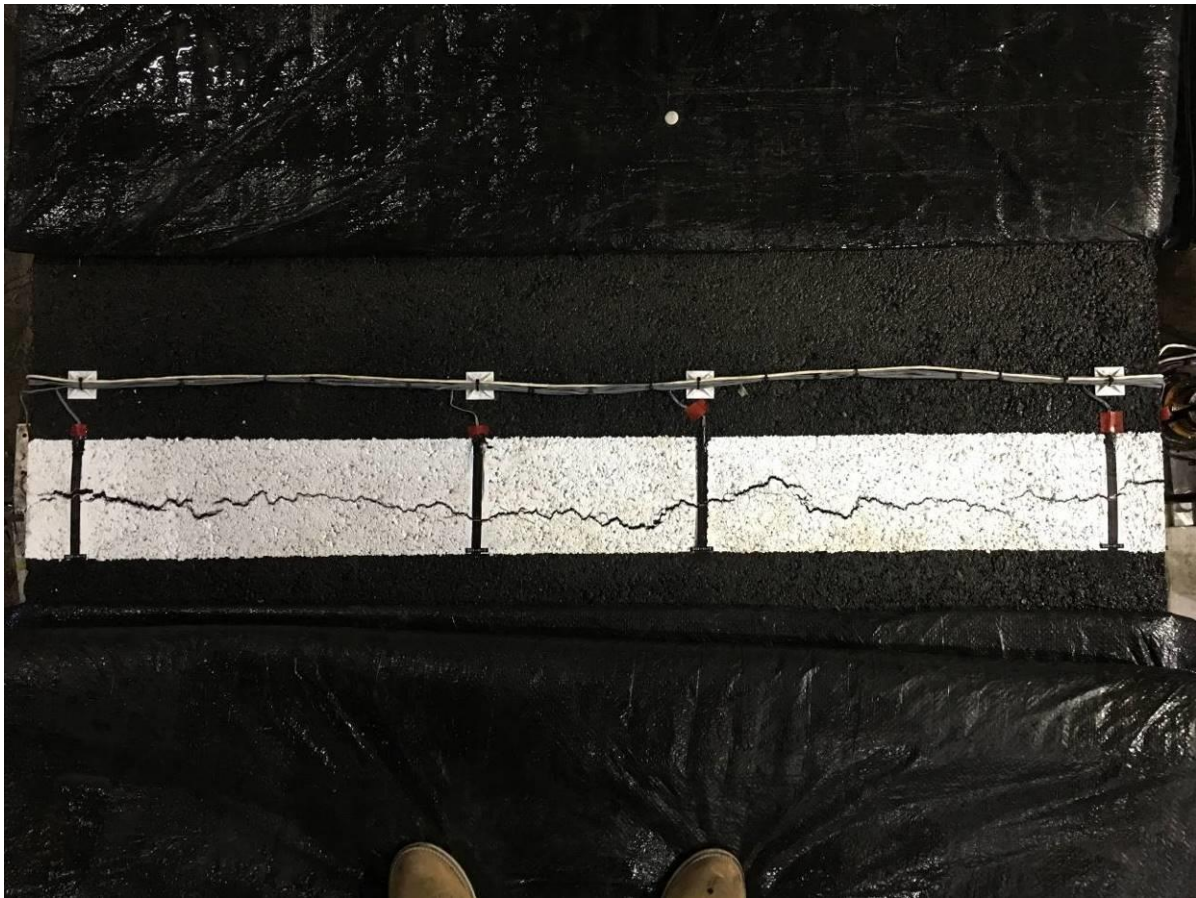
Fig 9 Surface crack on the north section

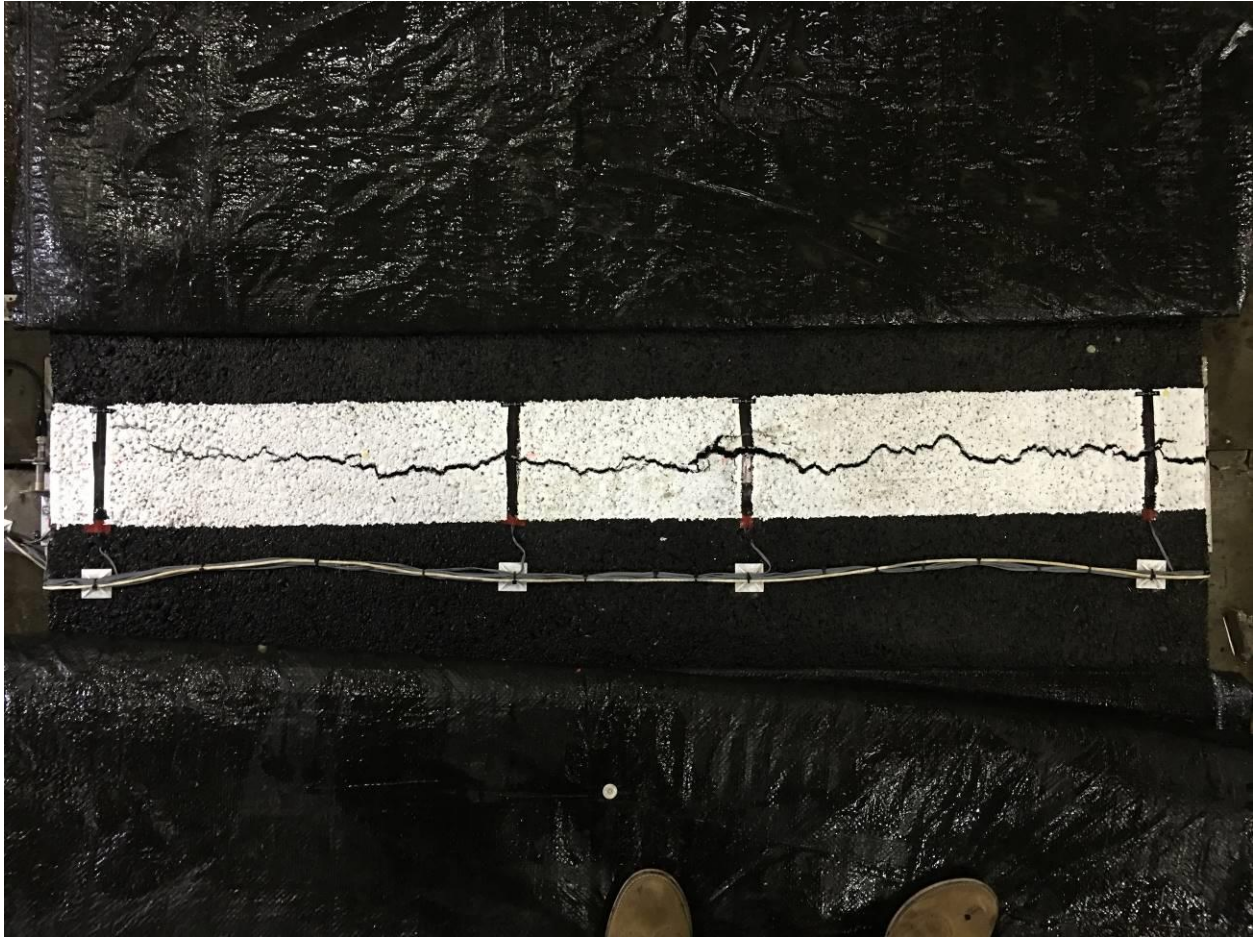
Fig 10 Surface crack on the south section
