## DO15 RC Indoor Phase VI Test Daily Notes

*Date: July 25, 2019*

*Cycle count: 5087*

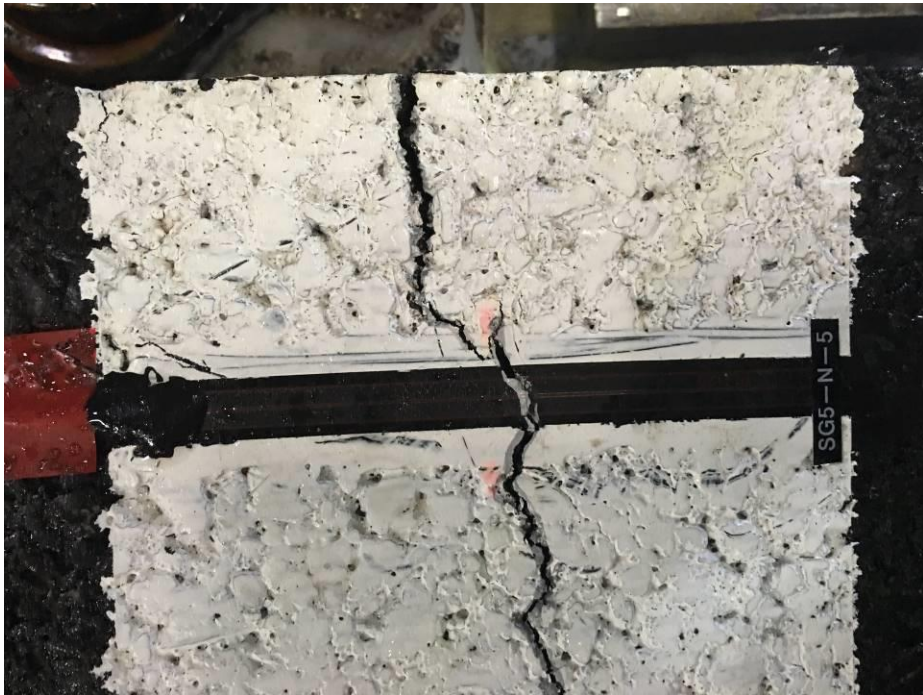
Fig 3 Surface crack on North Section reached outer edge
