## DO15 RC Indoor Phase VI Test Daily Notes

*Date: July 24, 2019*

*Cycle count: 4965*

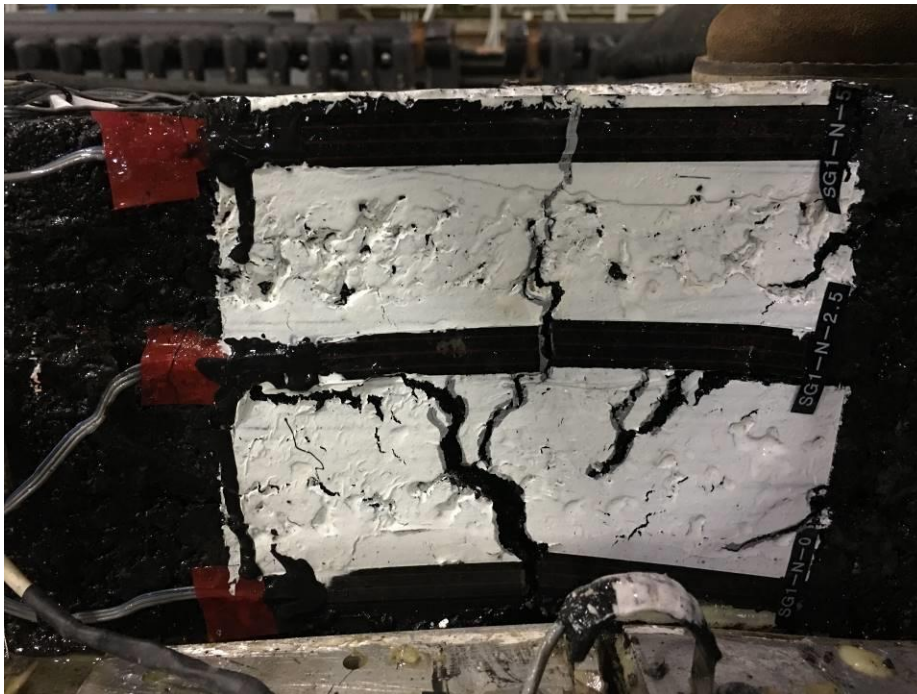
Fig 1 Bottom-up crack at north section inner vertical edge reached top surface

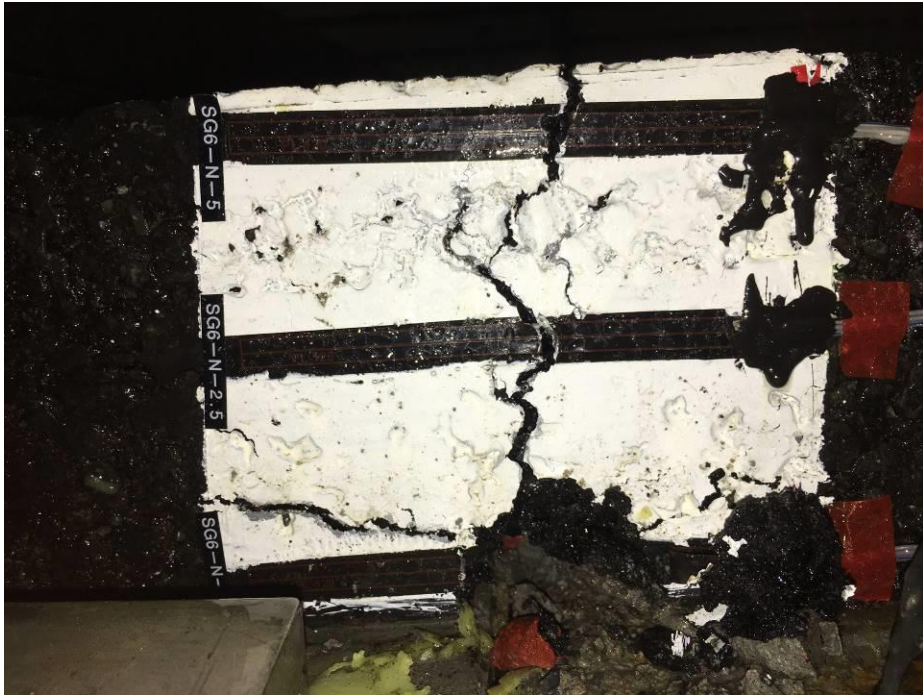
Fig 2 Bottom-up crack at north section outer edge reached top surface

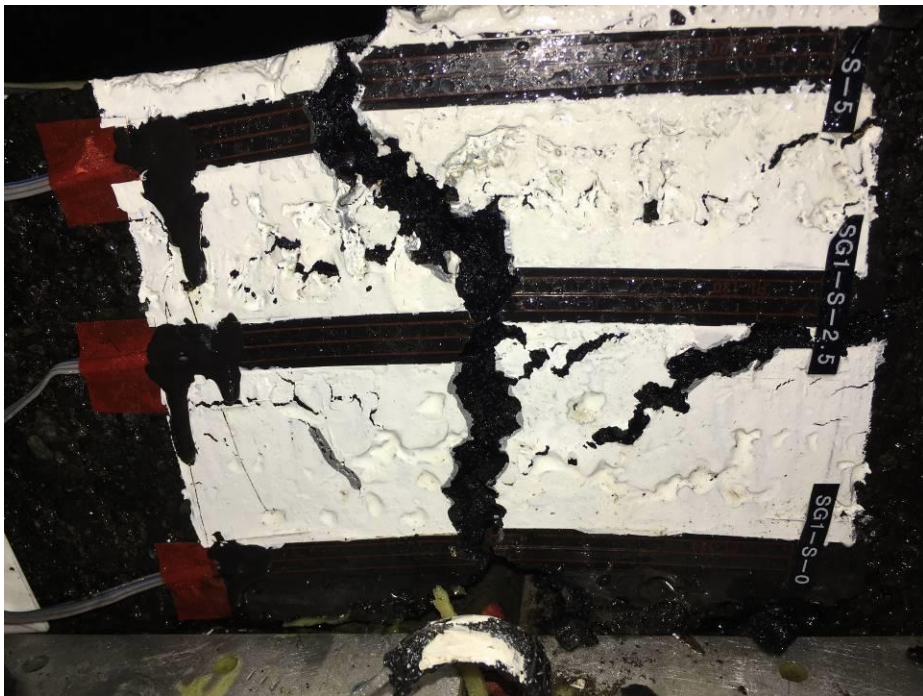
Fig 5 Bottom-up crack at inner vertical edge of south section reached top surface
