DO15 RC Indoor Phase VI Test Daily Notes

Date: July 31, 2019

Cycle count: 5803

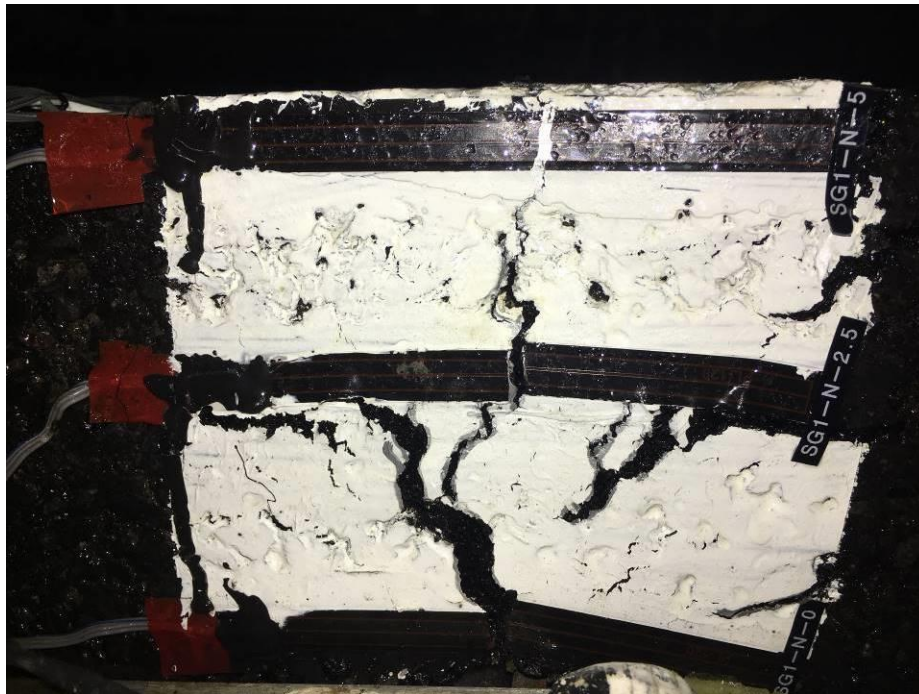
- Completed cracked, no further change.
- Bottom up crack at inner vertical edge as seen in Fig 1. Bottom up crack at outer vertical edge as seen in Fig 2.
- Surface crack connected to the bottom-up crack of the outer edge as seen in Fig 3, and the inner vertical edge shown in Fig 4.

Fig 1 Bottom-up crack at north section inner vertical edge reached top surface

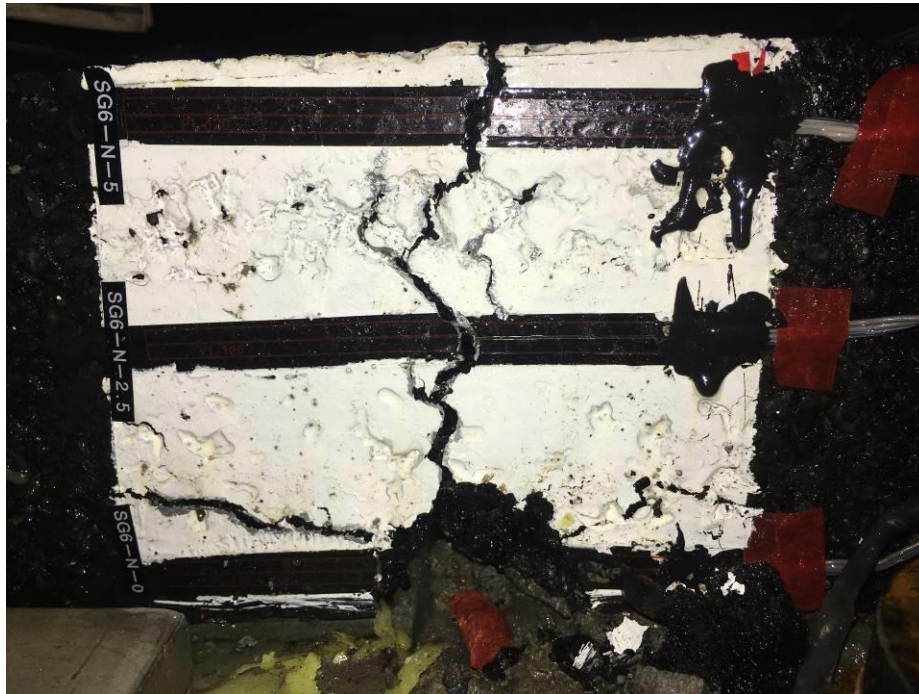
Fig 2 Bottom-up crack at north section outer edge reached top surface

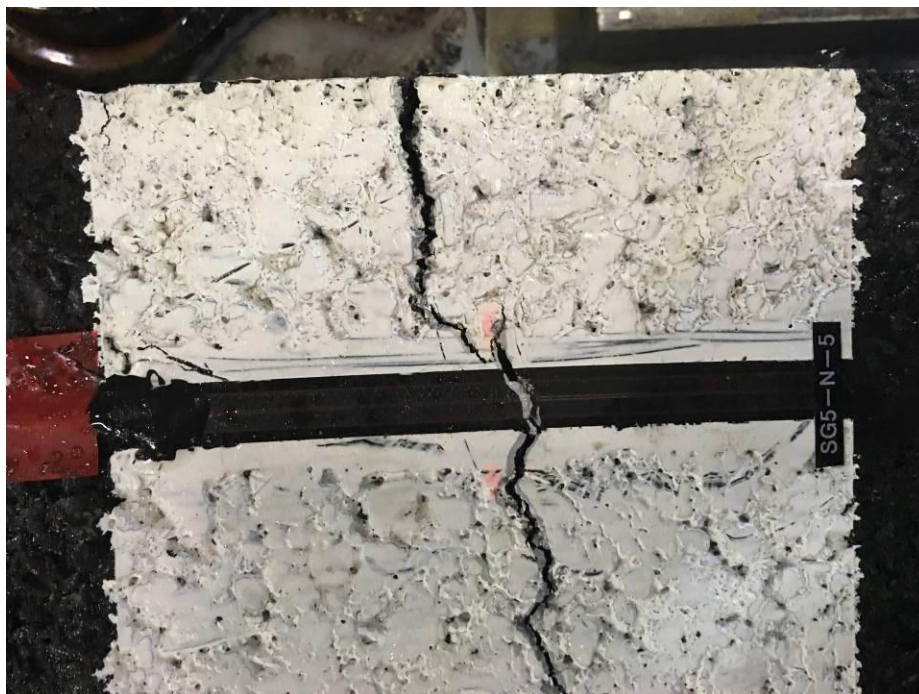
Fig 3 Surface crack on North Section reached outer edge
